**BUFFALO AND ERIE COUNTY INDUSTRIAL LAND DEVELOPMENT
CORPORATION**

**AGRIBUSINESS PARK MASTER PLAN, ERIE COUNTY, TOWN OF
EVANS, NEW YORK**

DRAFT GENERIC ENVIRONMENTAL IMPACT STATEMENT

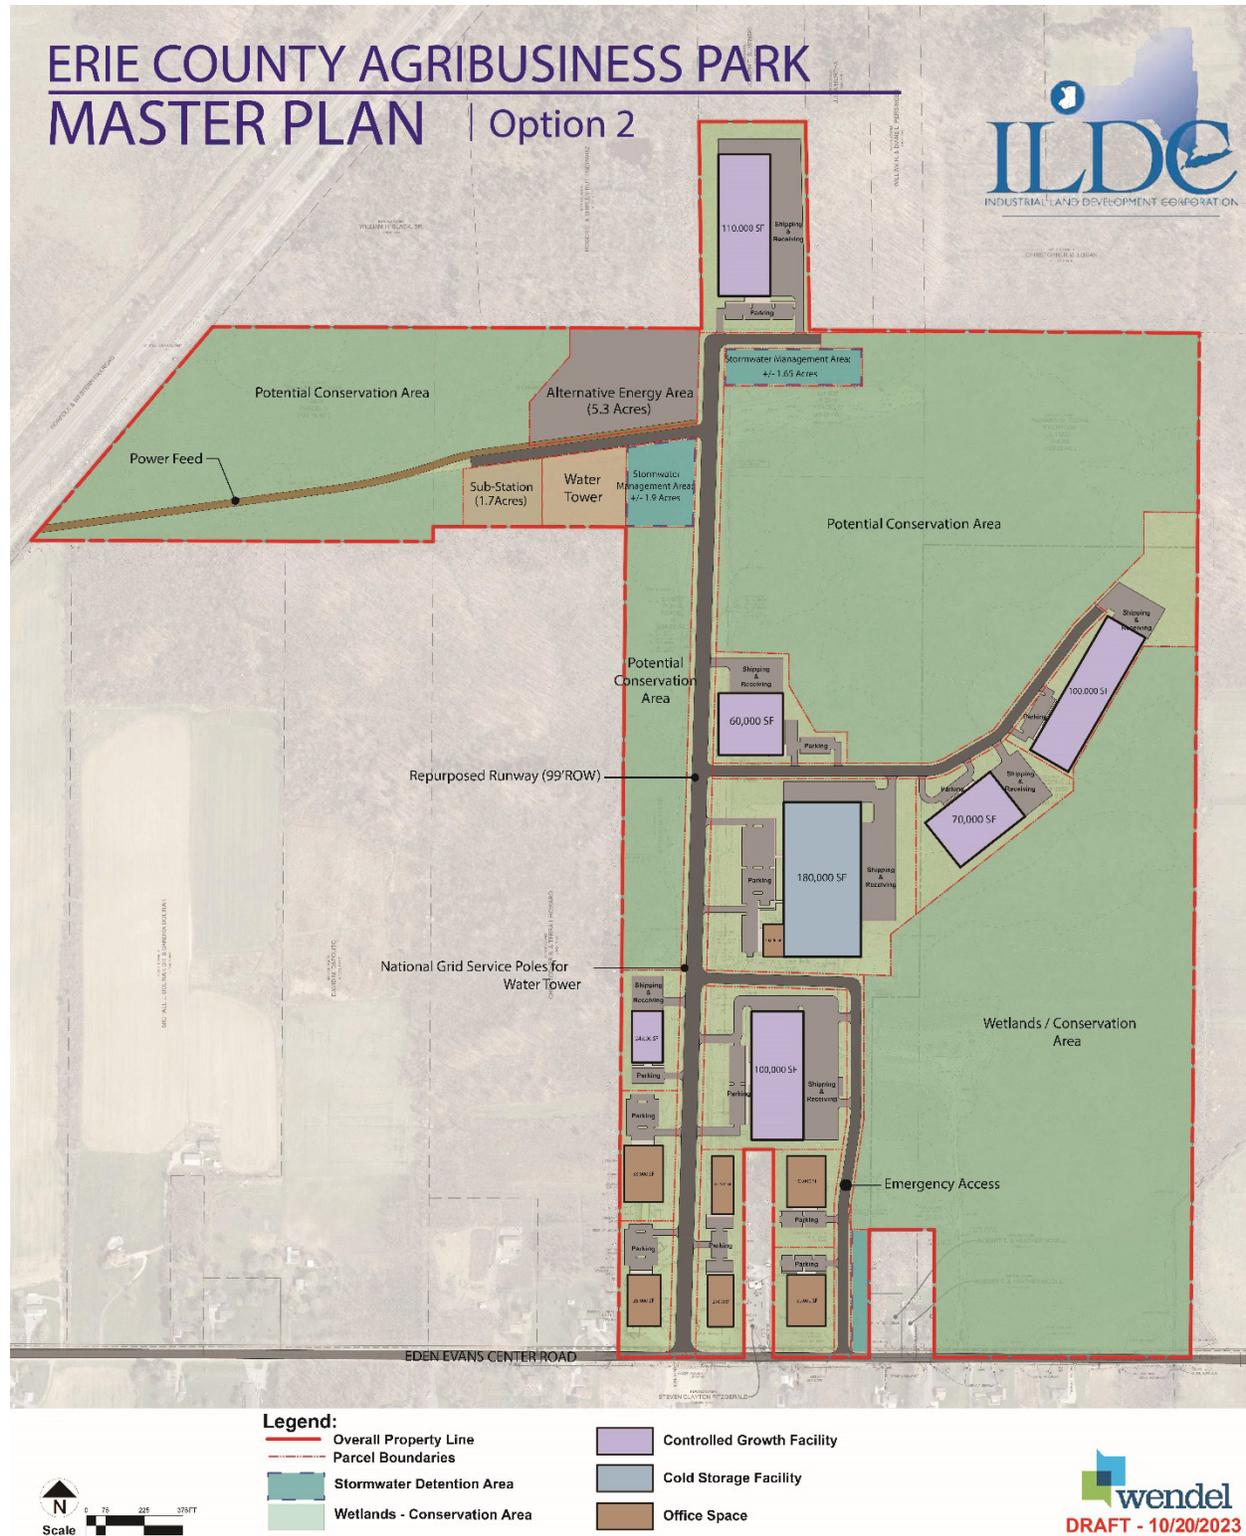
Figure 1-3 Potential Wetland/Conservation Area Option (Partial Build-Out)

Potential Wetland/Conservation Area Option: Option 2, Partial Build-Out: This alternative is designed to be flexible in terms of building lot placement and configuration, and road and utility layout. Option 2 was developed for implementation if site conditions warrant fewer lots being feasible for construction and development, and the net developable area is reduced. Differences under these scenarios would result in fewer lots being developed and a reduction in the overall length of roads and extent of utility installation required.

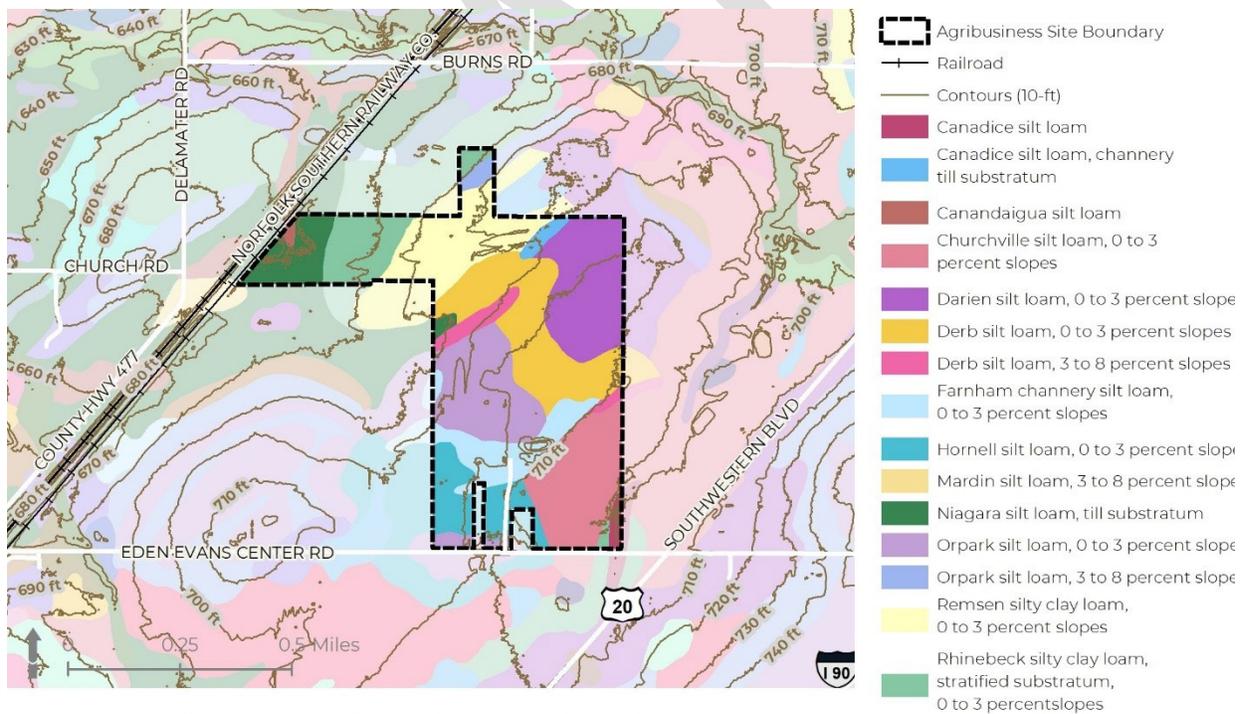
Figure 3-1 Soils Map

Appendix B provides a detailed soils report prepared using the online NRCS WSS tool; this report includes soil descriptions, hydrologic soil group maps, and representative soil slopes. Figure 3-1, below, depicts soils on the Project Site.

The soils on the Project Site range in classification from Hydrologic Soil Group (HSG) A/D¹ soils to HSG D soils. For the dual hydrologic group (A/D), the first letter is for drained areas and the second is for undrained areas. Only the soils that in their natural condition are in group D are assigned to dual classes. HSG D soils have a very slow water infiltration rate and generally prevent the downward flow of water. In soils covering approximately 80 percent of the Project Site, the depth to restrictive features is more than 80 inches. For the remaining 20 percent of the Project Site, it is approximately 30 inches. The depth of ground water varies from 6 to 21 inches across the numerous soil types found within the Project Site. These areas of shallow depth to water table will need to be taken into consideration in final design. The existing drainage class for the Project Site is generally characterized as somewhat poorly drained.

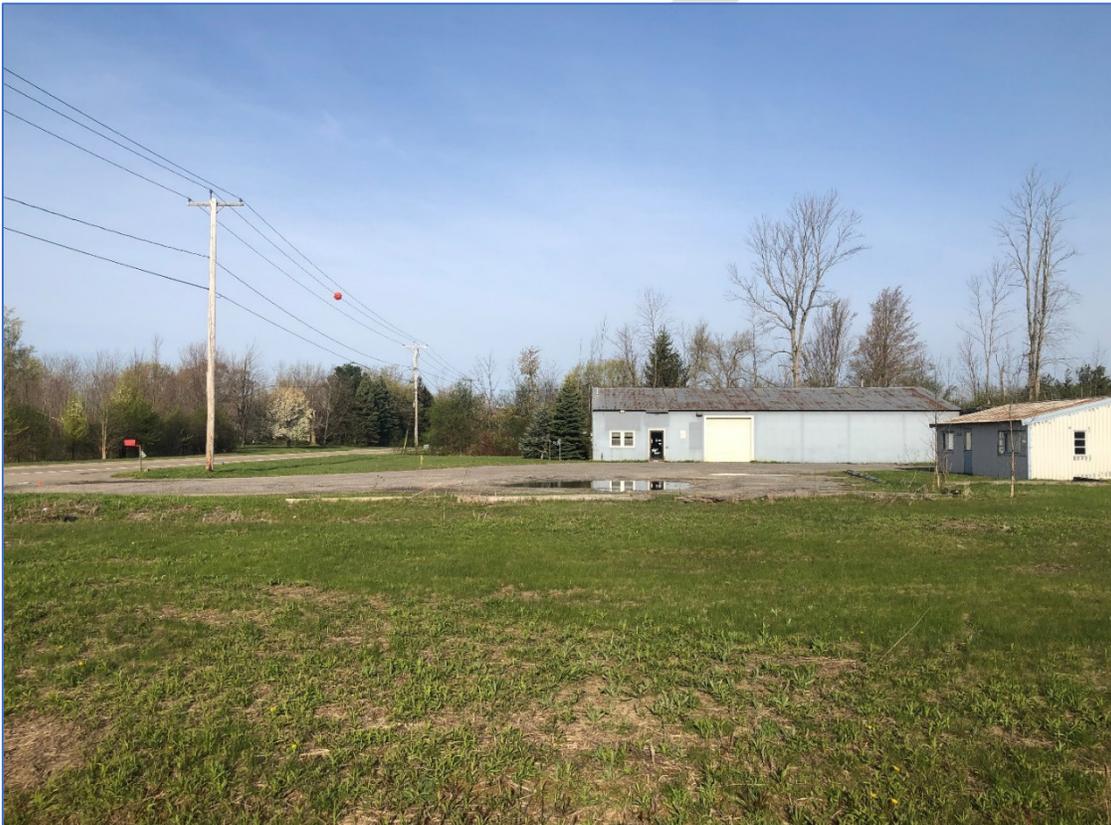
Figure 3-6 Existing Buildings along Frontage on Eden Evans Center Road

The Project Site is a former airport that is currently unoccupied. Near the Project Site's frontage on Eden Evans Center Road, the property is characterized by vestiges of its former use, including vacant structures that were formerly used as offices and hangars. Former runways are present, with a paved runway oriented north-south and a turf runway oriented east-west as well as a large, paved area that was used as an airplane tie-down area. Much of the remainder of the Project Site is undeveloped, with a mix of meadows and wooded areas. These undeveloped lands at the northern boundary of the Project Site are not visible from adjoining properties (see Figures 3-6 through 3-12).

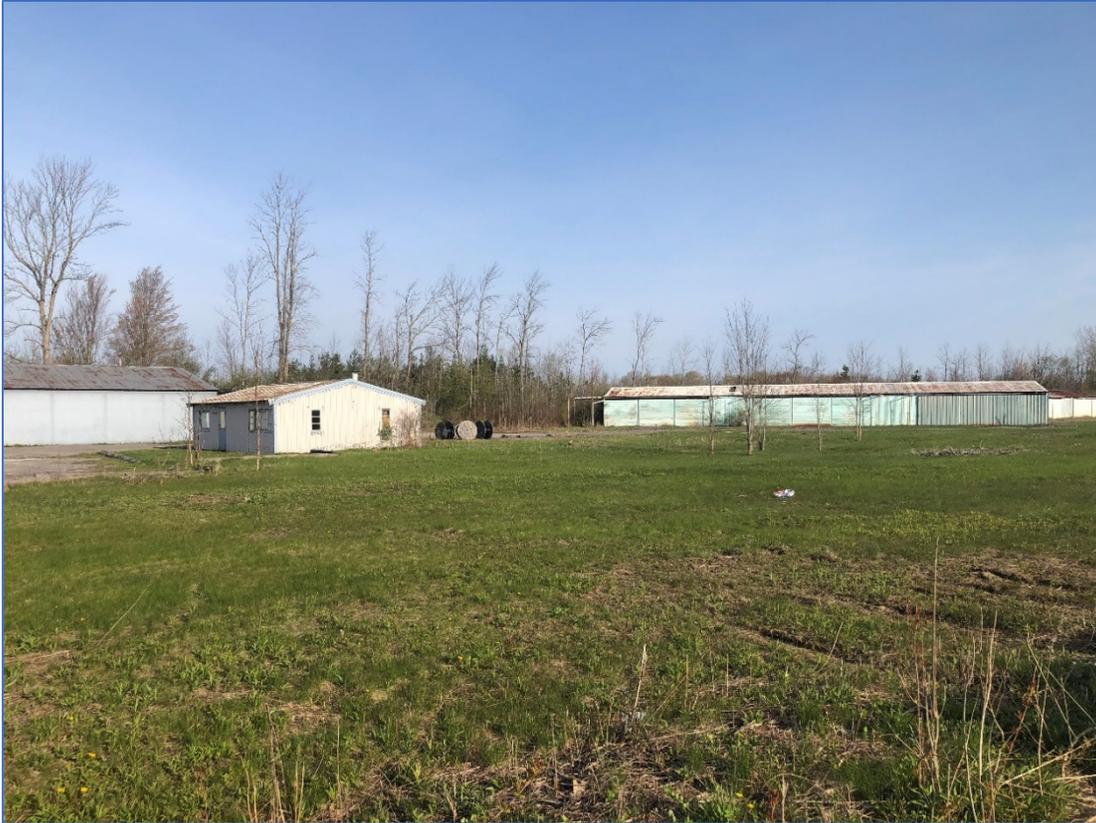
Figure 3-7 Former Hangars behind Office at Front of the Project Site

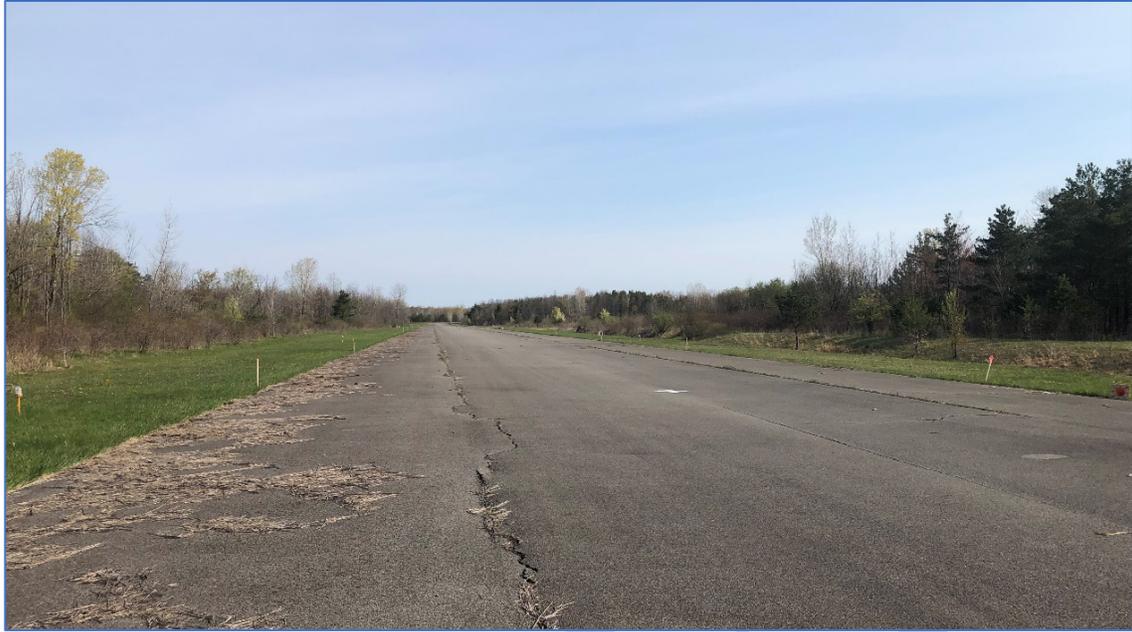
Figure 3-9 View Looking Northward Down Paved Runway with Wooded Areas on Either Side

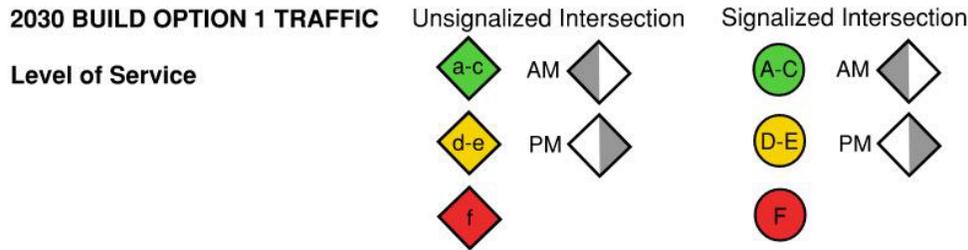
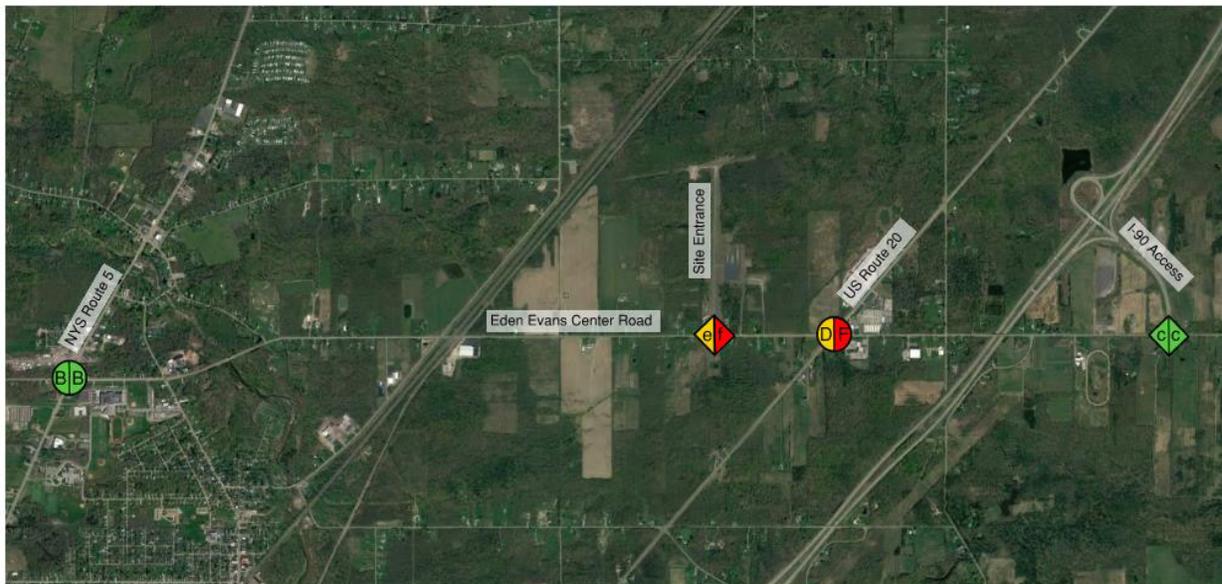
Figure 3-13 Option 1 Intersection Level of Service

eastbound and westbound movements on Eden Evans Center Road at US Route 20 exhibit failing levels of service and may require mitigation. As demonstrated by the queue analyses presented in Appendix B of the TIS, all approaches have sufficient length to accommodate the required 95th percentile queue length.

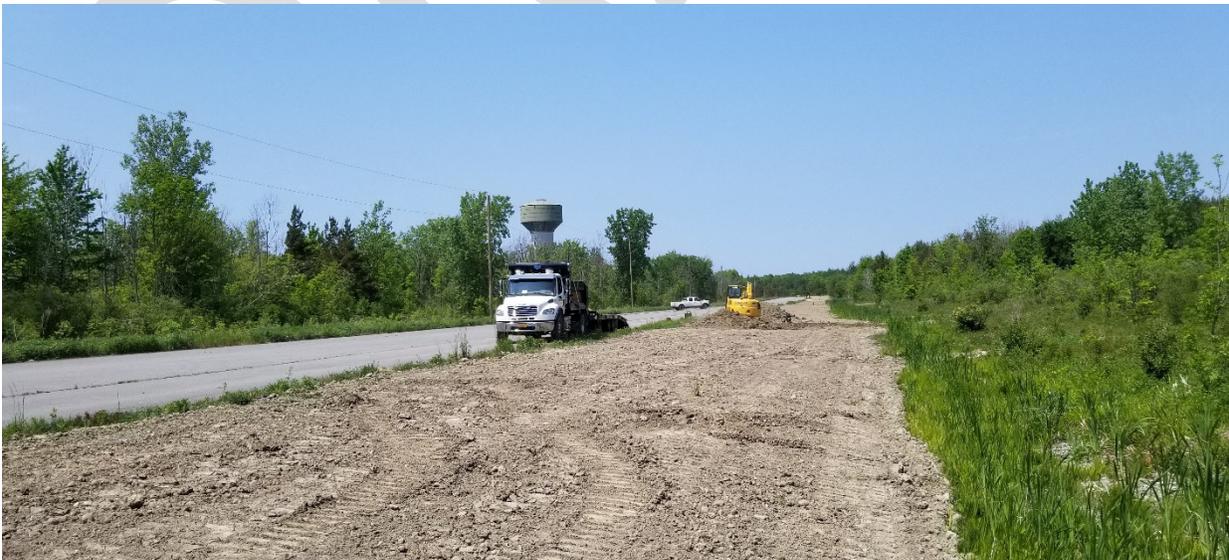
Figure 3-15 Water Tank and Mains Under Construction, Summer 2023

The Project Site is located within Town of Evans Water District and is a service area of the ECWA. The Town of Evans and ECWA recently constructed a water tank improvement project located on an approximately 2-acre parcel of land at the northwest corner of the paved runway on the Project Site. The town has indicated that the tank and associated infrastructure will be owned by the Town of Evans through a lease management agreement with ECWA. The ECIDA has provided funding to the Town of Evans for a capacity expansion of the proposed water tank in order to provide 500,000 gallons of water available for the sole purpose of the Project.

Two 12-inch polyvinyl chloride water lines extend to and from the tank site along the east side of the paved runway. It is in the best interest of the Project to connect to the ECWA lines along the east side of the runway to provide water service to the Project. Another option is to connect into the existing 10-inch water main in Eden Evens Center Road. New flow data should be obtained now that construction is completed on the tank project to determine the new flow characteristics in the system. Water modeling should be performed utilizing the new flow data in order to assess the various demands of potential tenants of the Project.

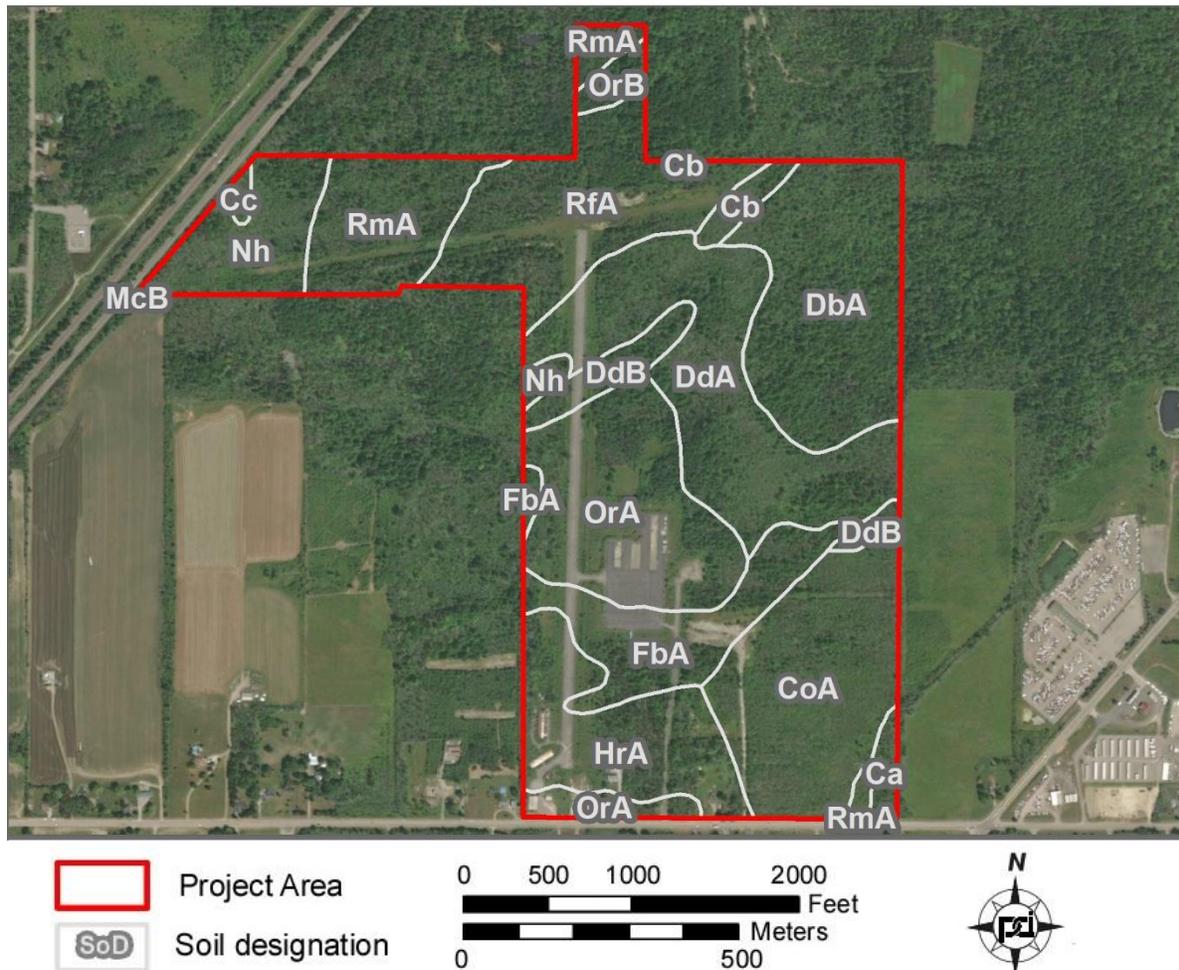
Figure 3. Soils within the project area (NRCS 2017).

Soils in the project area are summarized in Table 1 and shown in Figure 3 (Owens et al. 1986; NRCS 2017). Roughly 90-percent of the soils in the APE are "poorly drained" or "somewhat poorly drained". "Moderately well drained" soils are largely limited to an area with indicated Farnham channery silt loam (FbA).

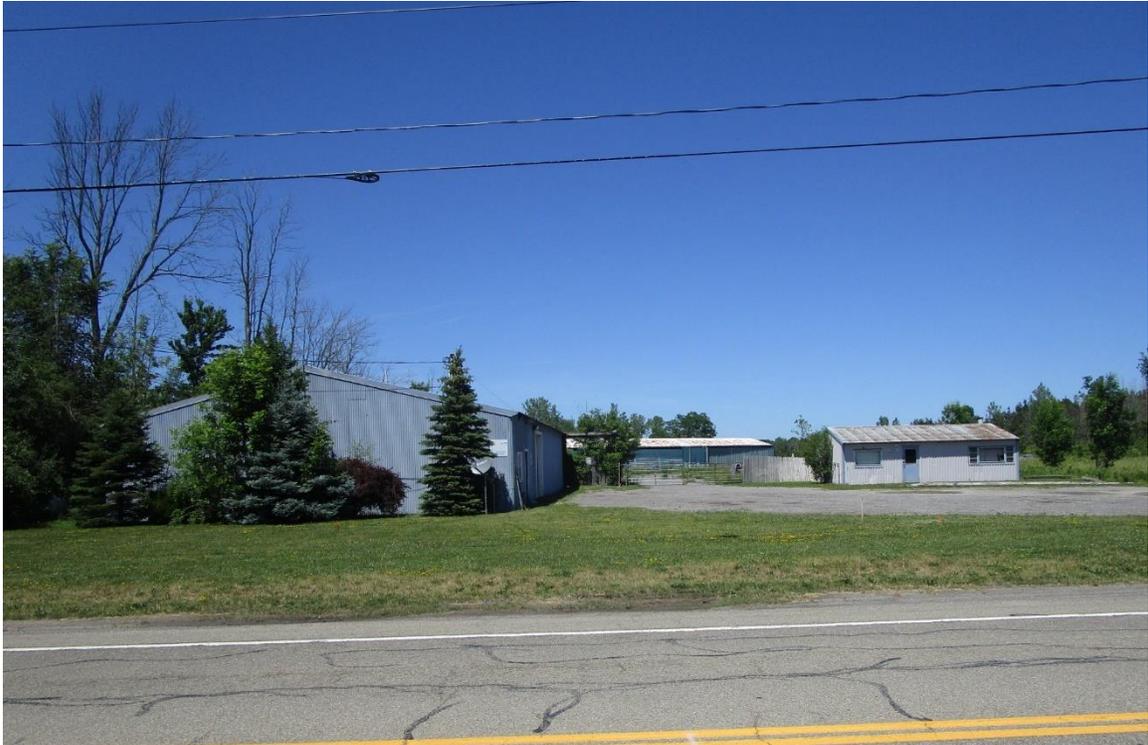
Figure 4. Former Angola Airport Office and Maintenance buildings within the southwest portion of the project area, facing north from Eden Evans Center Road (Panamerican 2021).

Man-Made Features and Alterations. The project area includes a former aircraft facility (Figures 4 through 6) which consists of a complex of small buildings (office, maintenance facility, and two airplane hangars) along Eden Evans Center Road, a 3,212-ft by 60-ft (979-m x 18-m) asphalt landing strip (#01/19; north-south), a 2,800-ft by 60-ft (853-m x 18-m) turf and gravel runway (# 09/27; east-west), and a 360-ft by 680-ft (110-m x 207-m) paved aircraft parking area on the east side of the asphalt landing strip (Freeman 2020; see Section 4 for current conditions of abandoned airport). Dense woods cover most of the project area.

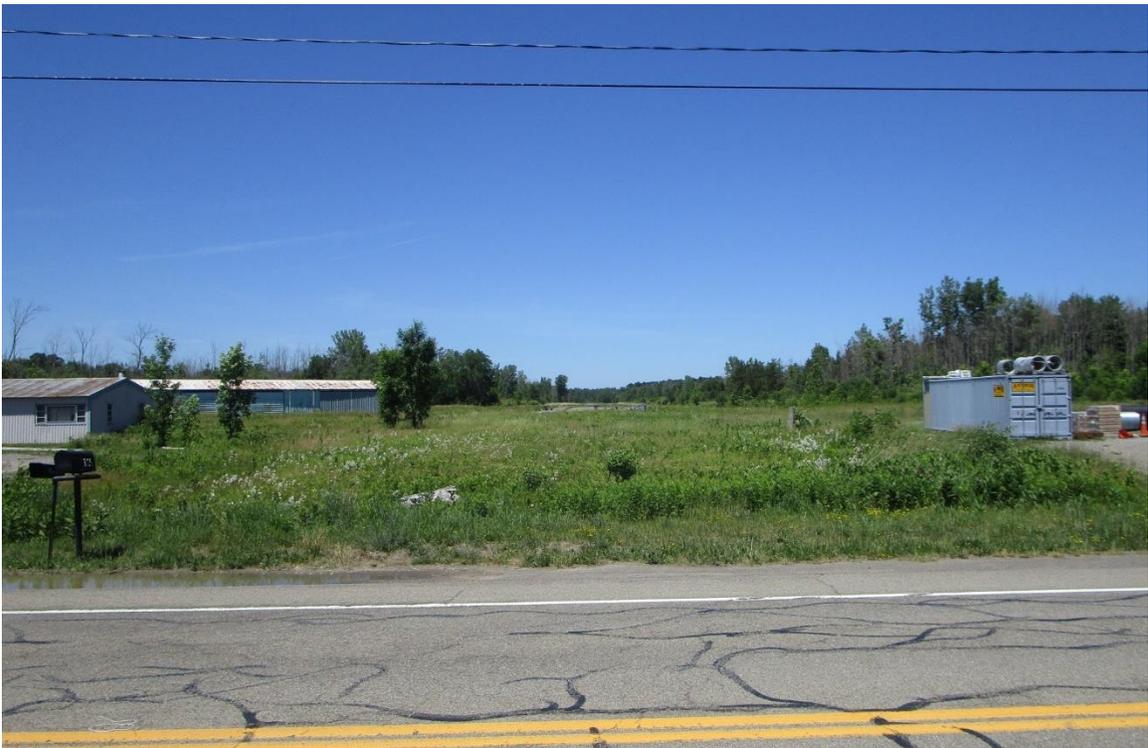
Figure 5. Former Angola Airport airplane hangars situated on west side of asphalt landing strip, facing north from Eden Evans Center Road (Panamerican 2021).

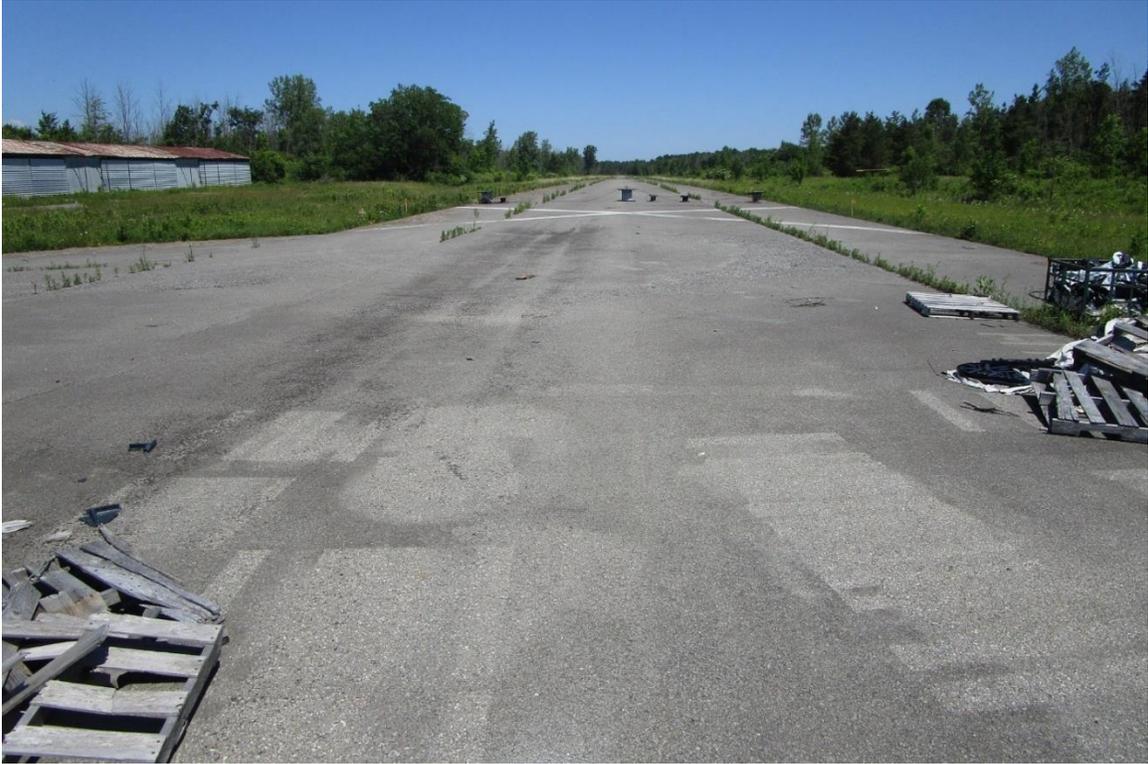
Figure 6. Former Angola Airport asphalt landing strip, facing north (Panamerican 2021).

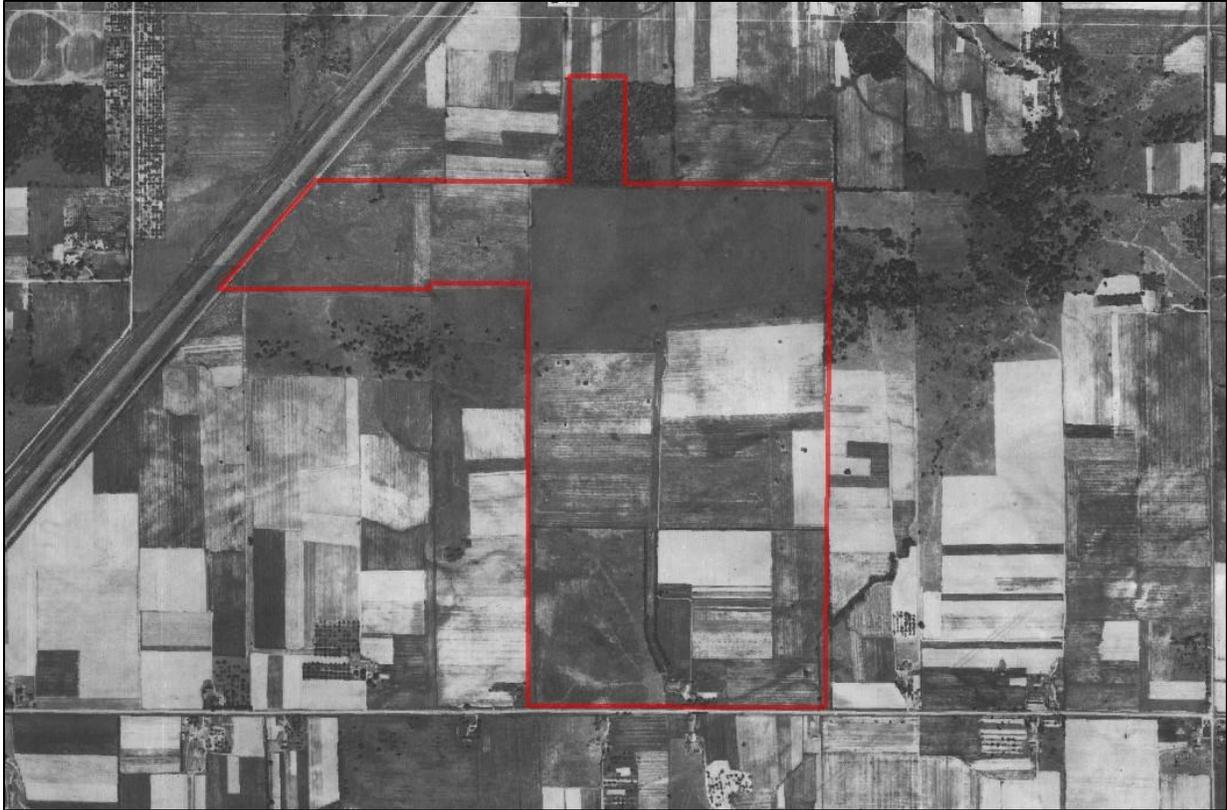
Figure 14. Approximate location of the project area (red polygon) in 1926 (ECDPW 1926).

1926 aerial (Figure 14). The 1926 aerial photograph shows the project area comprised of many agricultural fields with a centrally located field access road extending northwest then north from the former *P.R. Clark / Phillip Clark / F. Rehberg* farmstead. Two farmsteads stand out opposite the project area, the western most one appearing where the *Mosher/Nichols* structure is shown on earlier referenced maps, and the easternmost farm opposite the *Clark/Rehberg* farm – approximately where a house at 1561 Eden Evans Center Road is today.

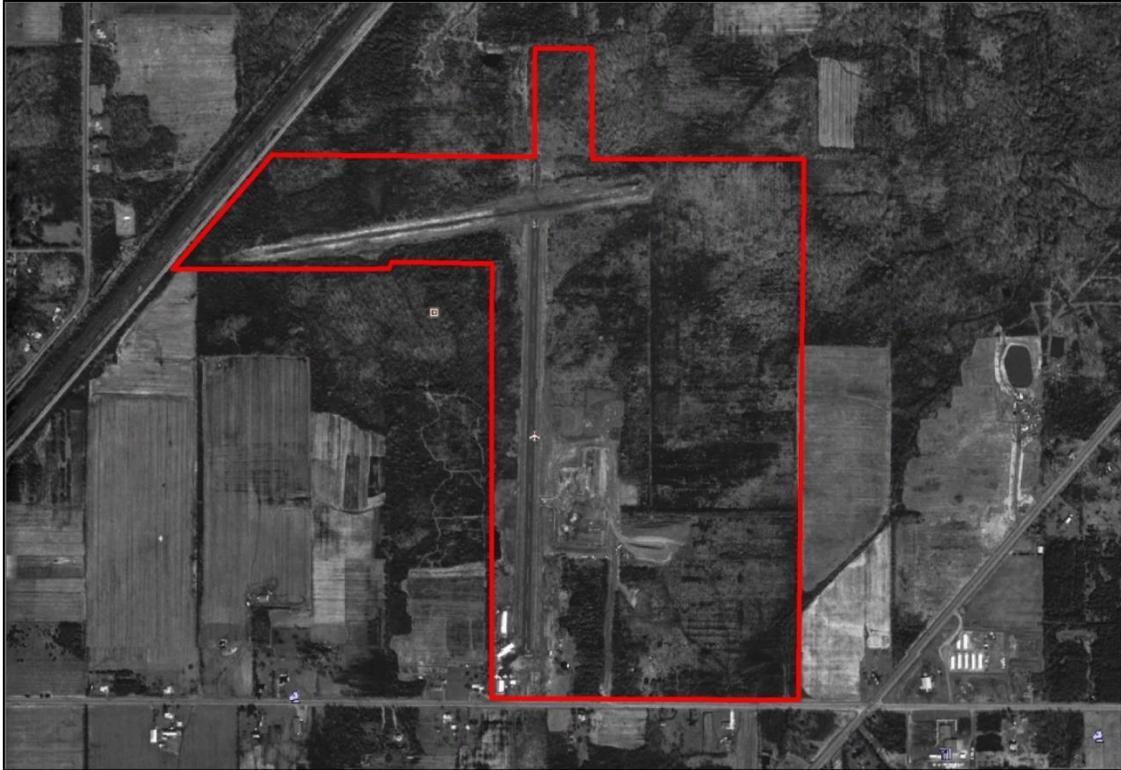
Figure 16. Approximate location of the project area in 1994 (*Google Earth 1994*).

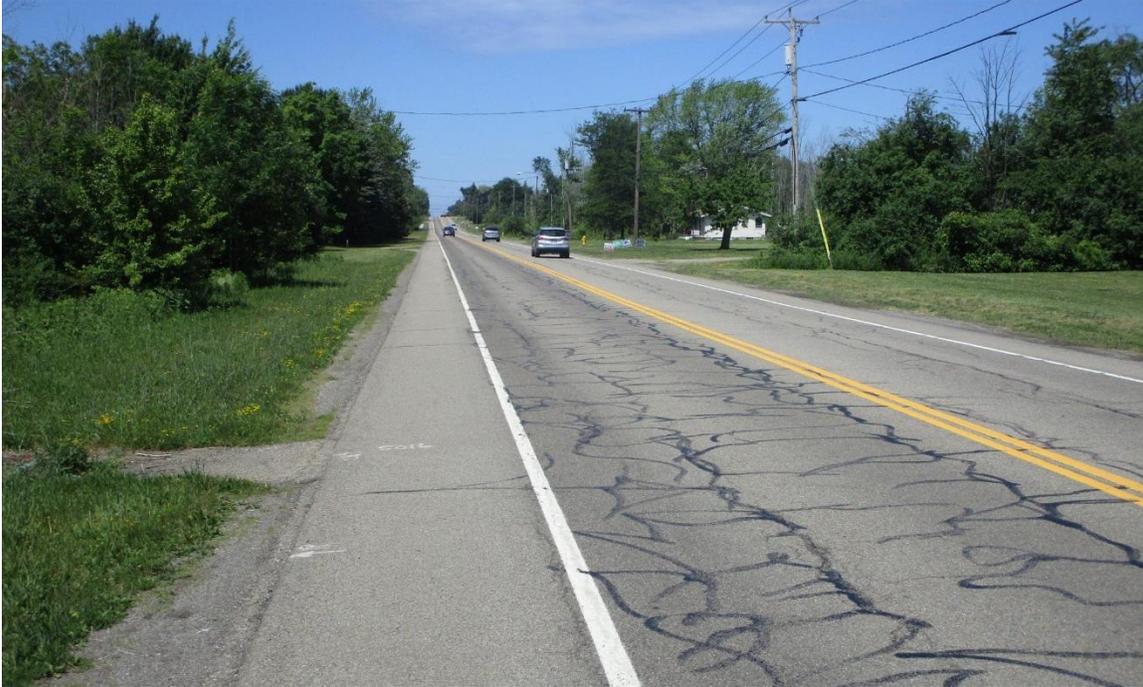
Photograph 1. Project is located within a rural residential/agricultural setting. View is facing west along Eden Evans Center Road from the southwest entrance of the project (*Panamerican 2021*).

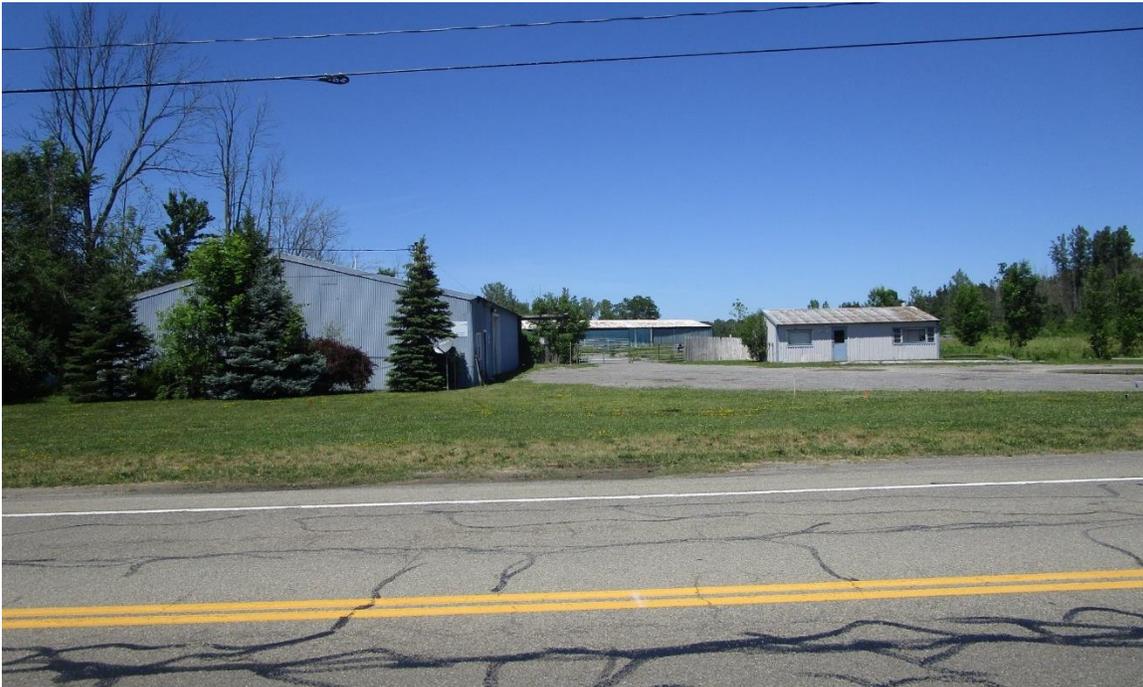
Photograph 2. Former Angola Airport buildings (maintenance building and office, with one of two hangars visible at center), facing north from Eden Evans Center Road (*Panamerican 2021*).

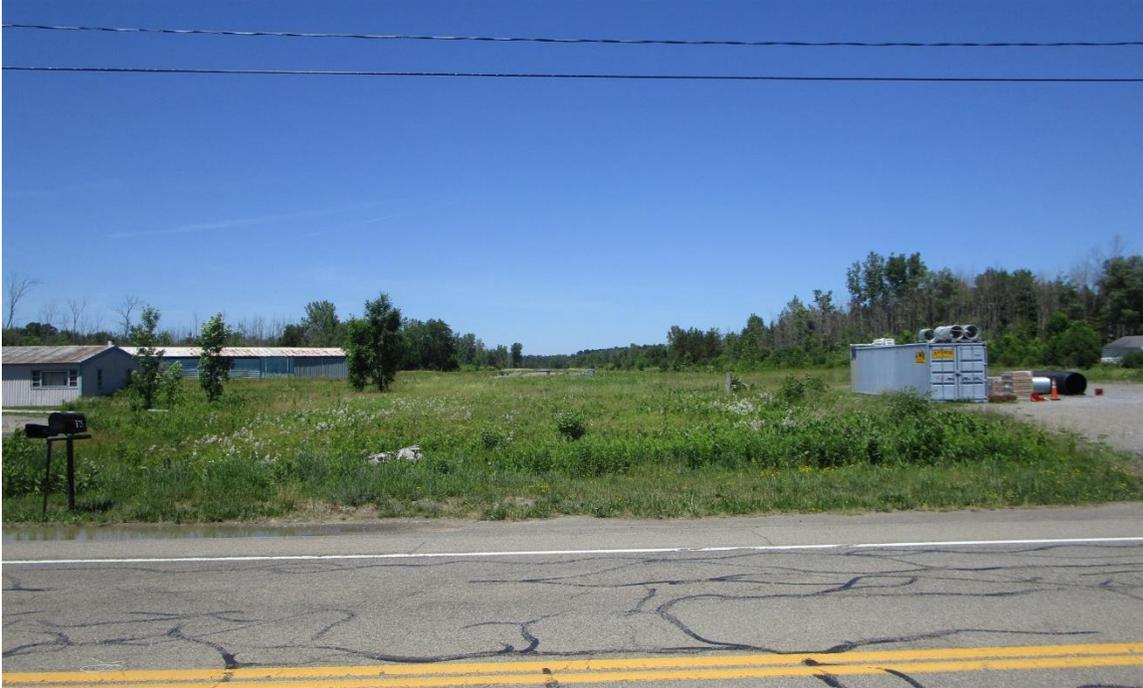
Photograph 3. Former Angola Airport office buildings at far left (office and one of two hangars), facing north from Eden Evans Center Road along one of two airstrips within the project area (*Panamerican 2021*).

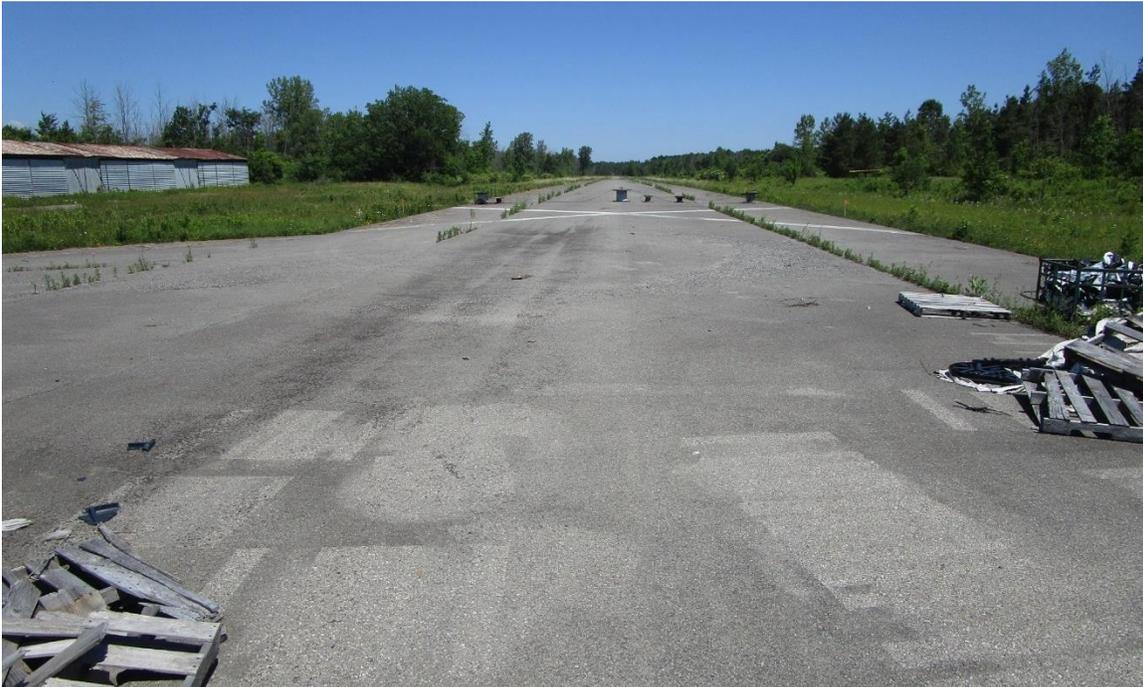
Photograph 4. Former Angola Airport asphalt airstrip aligned north-south (facing north from south terminus). A second gravel airstrip aligned east-west is located within the north portion of the project (*Panamerican 2021*).

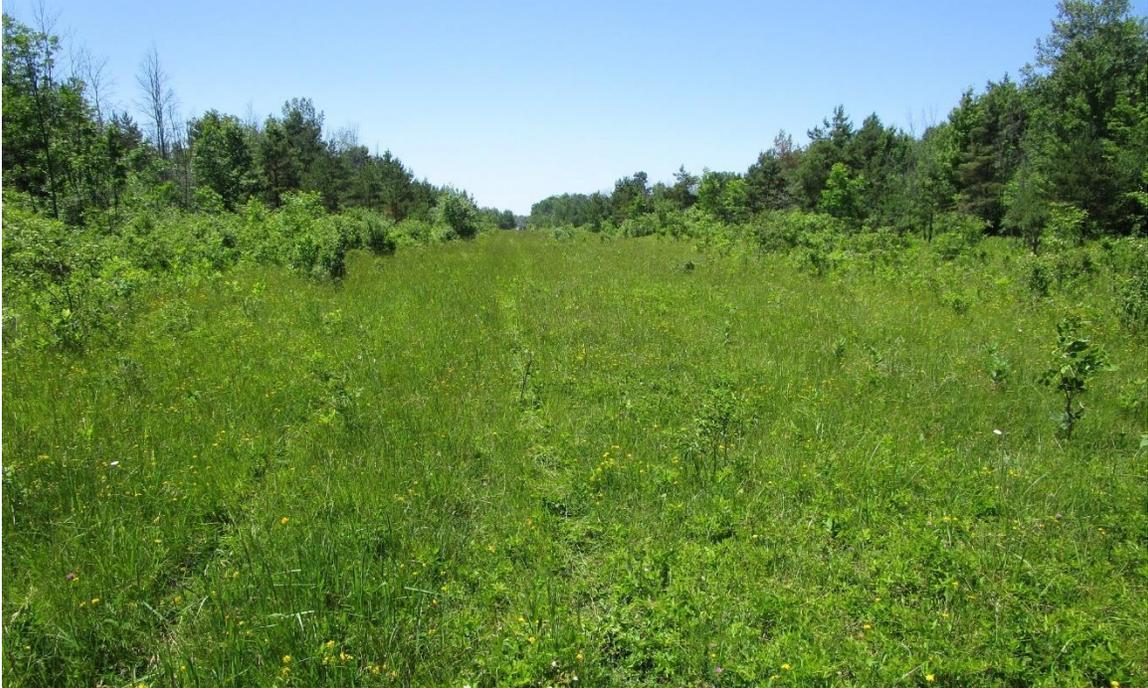
Photograph 5. Former Angola Airport gravel airstrip aligned east-west is located within the north portion of the project. View is facing west from east-end of the airstrip (*Panamerican 2021*).

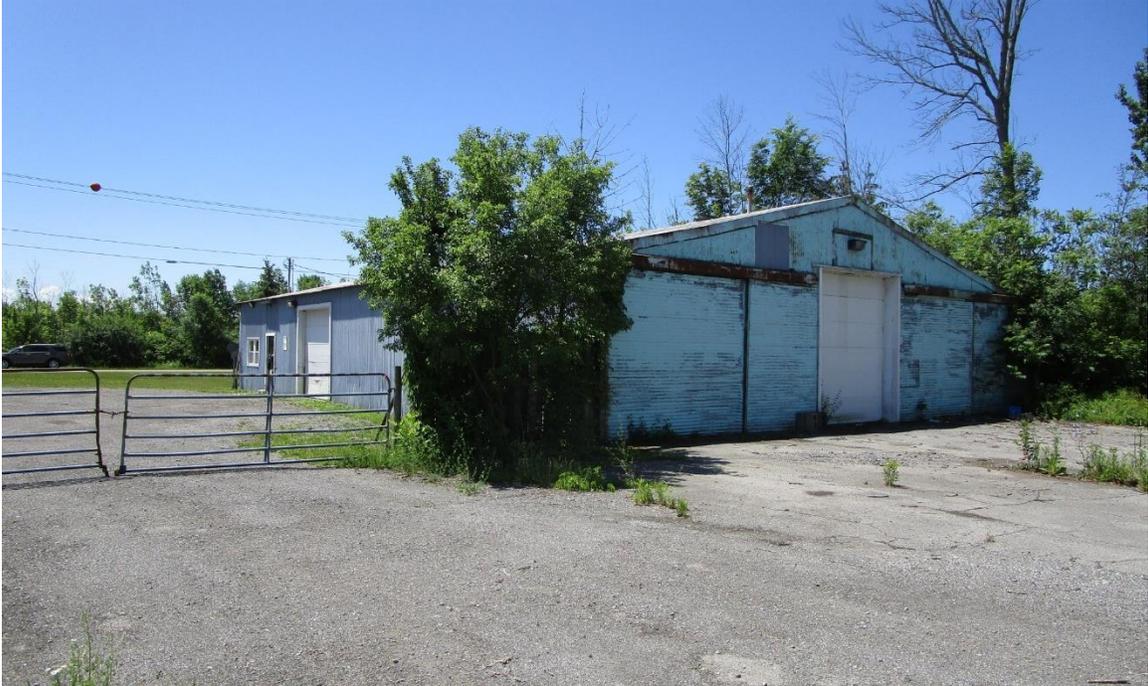
Photograph 7. Northeast elevation of maintenance/office building (1526 Eden Evans Center Road) shown in Photograph 2, facing southwest (*Panamerican 2021*).

As described in Section 1.2 (Man-Made Features and Alterations) – the project area includes a former airfield which consists of a complex of small buildings (office, maintenance facility, and two airplane hangars) along Eden Evans Center Road (see Appendix A: Photographs 7 through 10), in addition to a 3,212-ft by 60-ft (979-m x 18-m) asphalt landing strip (aligned north-south) with an adjacent directional air indicator (see Appendix A: Photographs 4 and 11), a 2,800-ft by 60-ft (853-m x 18-m) turf and gravel runway (aligned east-west; see Appendix A: Photograph 5), and a 360-ft by 680-ft (110-m x 207-m) paved aircraft parking area on the east side of the asphalt landing strip (see Appendix A: Photograph 12).

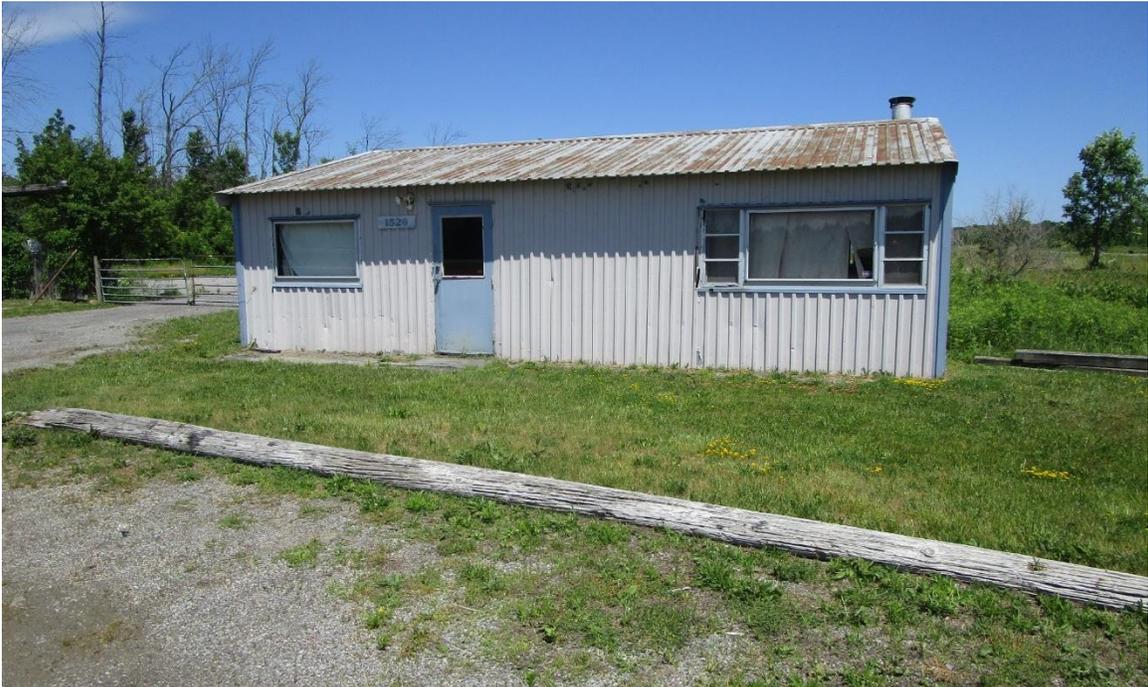
Photograph 8. South elevation of office building (1526 Eden Evans Center Road) shown in Photograph 2, facing north (*Panamerican 2021*).

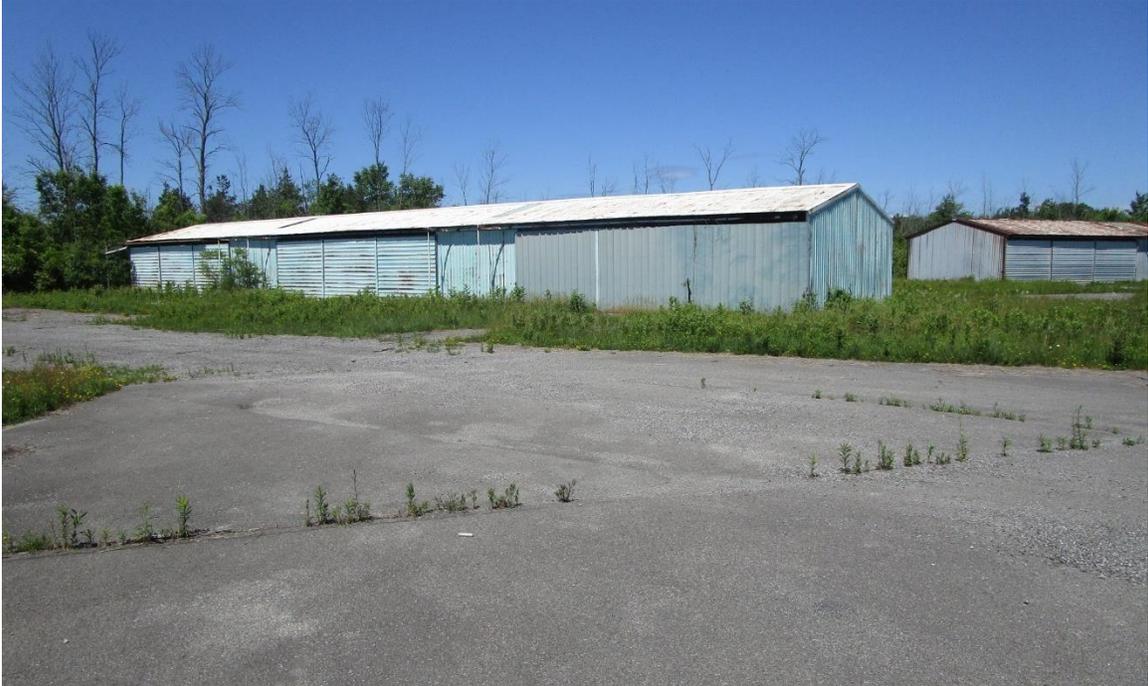
Photograph 9. Southeast elevation of one of two hangars (the second one is at center-right) located on west side of the asphalt airstrip, facing northwest (*Panamerican 2021*).

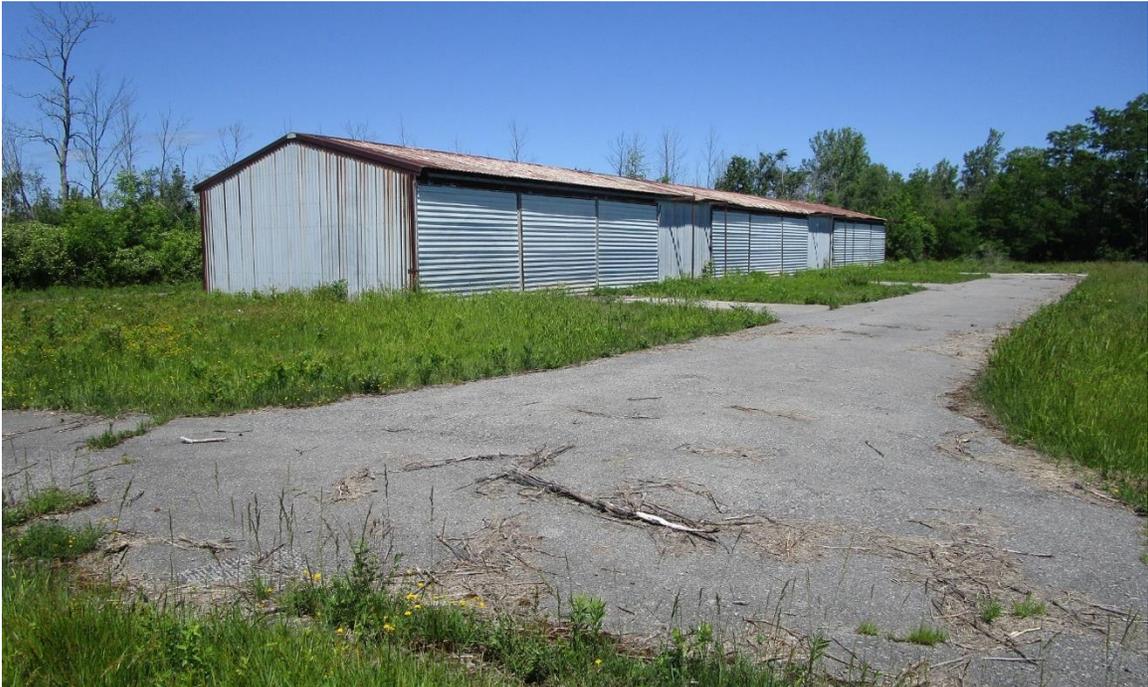
Photograph 10. Southeast elevation of the second hangar located on the west side of the asphalt airstrip, facing northwest (*Panamerican 2021*).

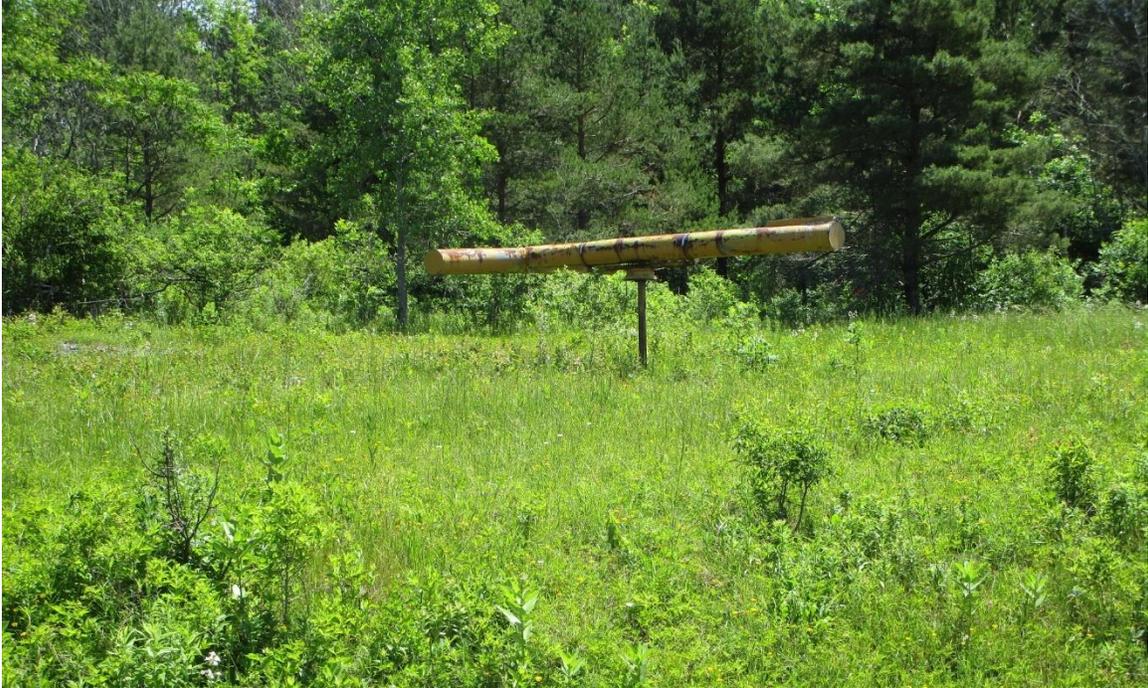
Photograph 11. Directional air indicator located on east side of the asphalt airstrip, facing east (*Panamerican 2021*).
