**BUFFALO AND ERIE COUNTY INDUSTRIAL LAND DEVELOPMENT
CORPORATION**

**AGRIBUSINESS PARK MASTER PLAN, ERIE COUNTY, TOWN OF
EVANS, NEW YORK**

DRAFT GENERIC ENVIRONMENTAL IMPACT STATEMENT

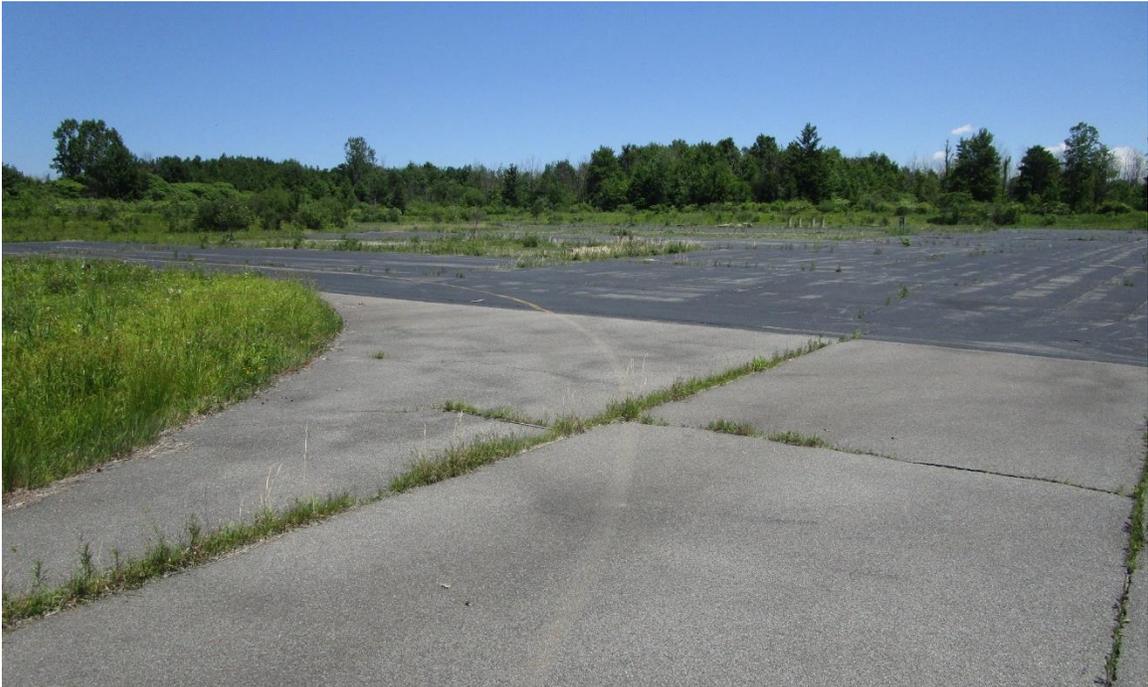
Photograph 12. Paved airplane parking area located on east side of the asphalt airstrip. View is facing northeast (*Panamerican 2021*).

As described in Section 1.2 (Man-Made Features and Alterations) – the project area includes a former airfield which consists of a complex of small buildings (office, maintenance facility, and two airplane hangars) along Eden Evans Center Road (see Appendix A: Photographs 7 through 10), in addition to a 3,212-ft by 60-ft (979-m x 18-m) asphalt landing strip (aligned north-south) with an adjacent directional air indicator (see Appendix A: Photographs 4 and 11), a 2,800-ft by 60-ft (853-m x 18-m) turf and gravel runway (aligned east-west; see Appendix A: Photograph 5), and a 360-ft by 680-ft (110-m x 207-m) paved aircraft parking area on the east side of the asphalt landing strip (see Appendix A: Photograph 12).

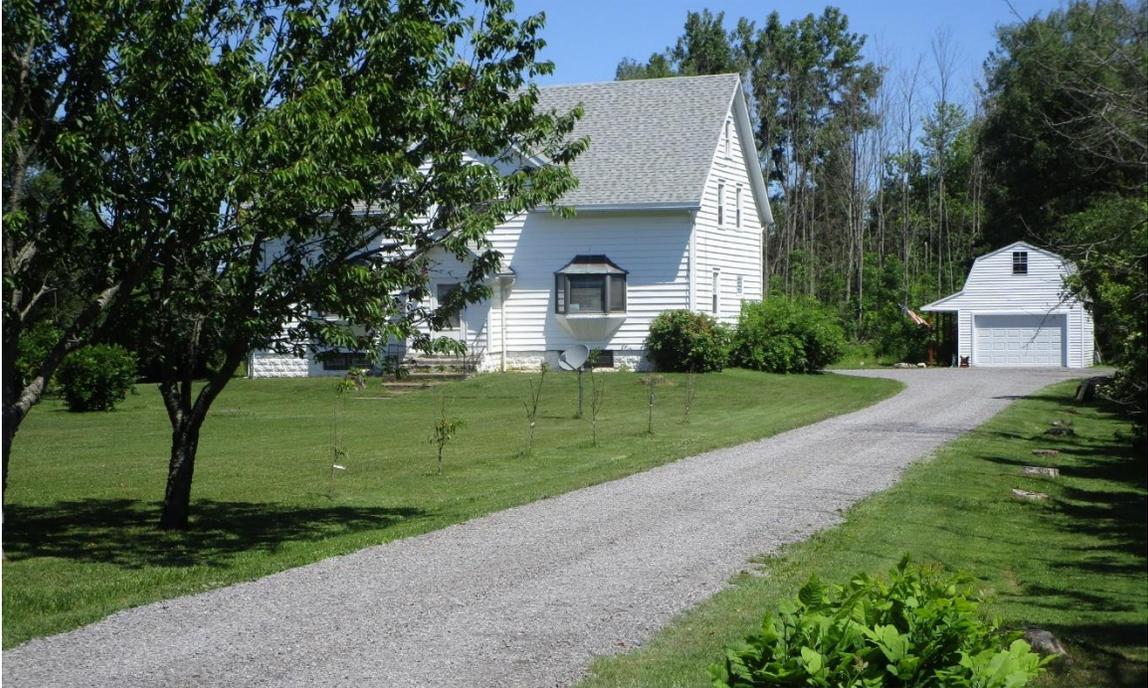
Photograph 13. South elevation of ca. 1948 residence located within the south portion of the project at 1548 Eden Evans Center Road, facing north (*Panamerican 2021*).

The proposed project area also contains two residences: a ca. 1948 structure at 1548 Eden Evans Center Road (see Appendix A: Photograph 13) and a ca. 1882 structure with detached garage at 1576 Eden-Evans Center Road (see Appendix A: Photograph 14).

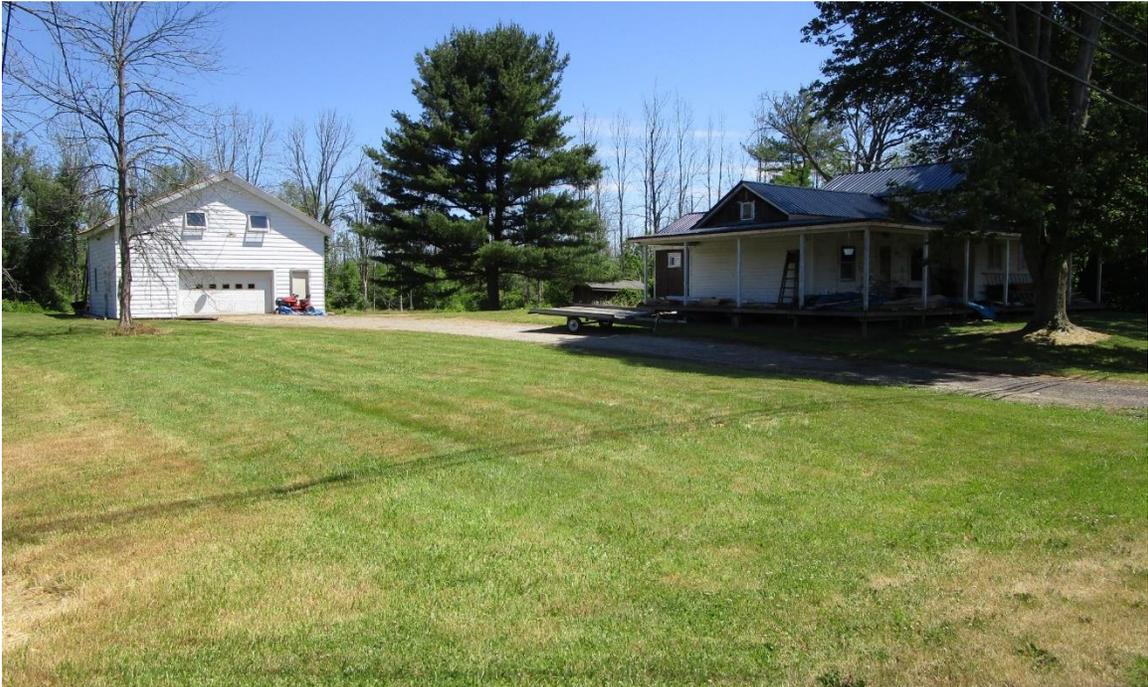
Photograph 14. Southwest elevation of ca. 1882 residence located within the south portion of the project at 1576 Eden Evans Center Road, facing northeast (*Panamerican 2021*).

Recommendations. A Phase 1B cultural resources investigation is recommended for an approximate 500-ft by 500-ft (5.7-acre) portion of the project (Figure 20) encompassing the nineteenth century farmhouse at 1576 Eden Evans Center Road (see Figures 8 and 18).

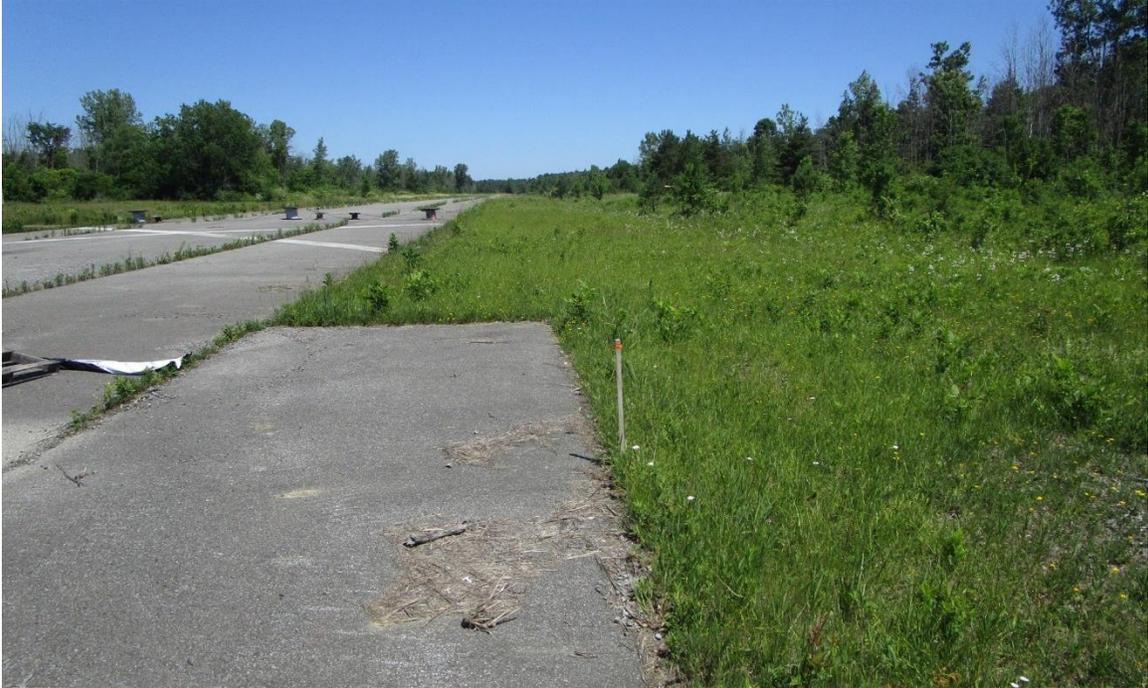
Photograph 15. Grading disturbance approximately between 50-ft and 75-ft (15-m and 23-m) width noted along edges of both runways. View is facing north (*Panamerican 2021*).

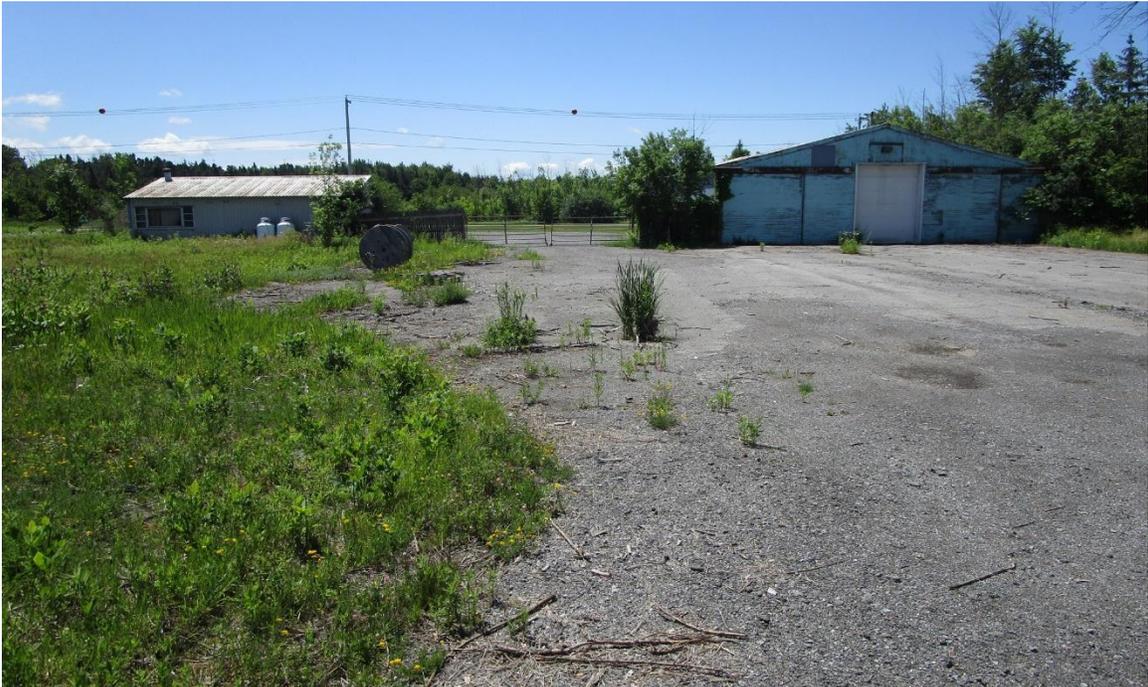
Photograph 16. Multiple paved/gravel road disturbances extend between and around buildings associated with the former Angola Airport facility. View is facing south towards Eden Evans Center Road (*Panamerican 2021*).

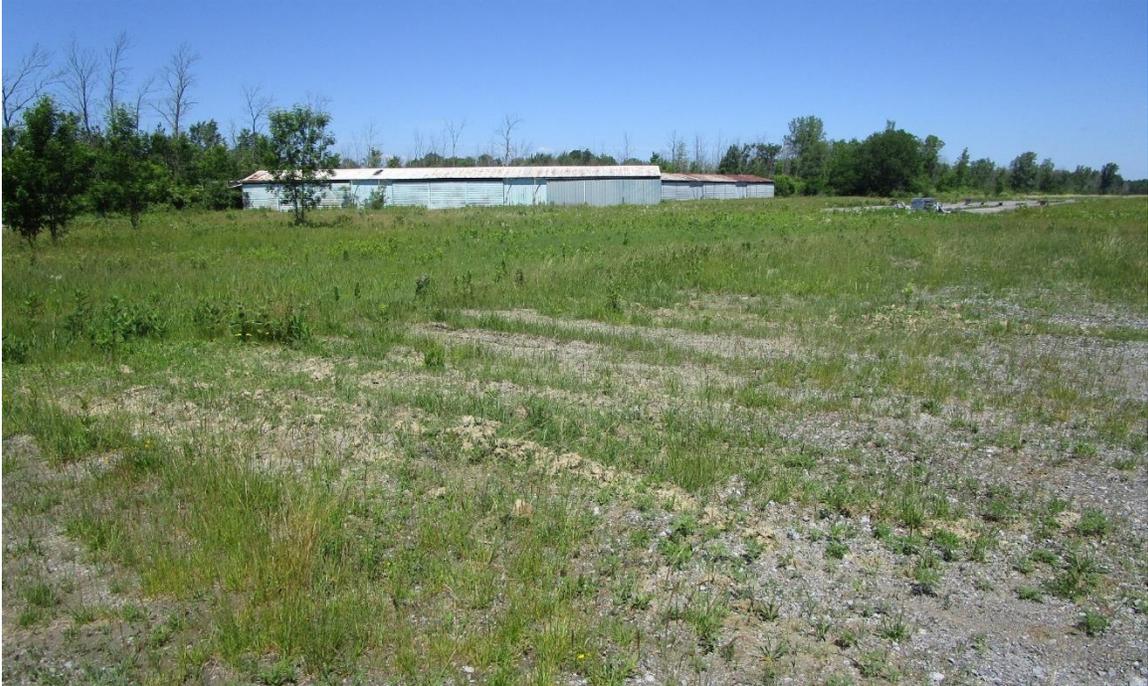
Photograph 17. Gravel fill extends between the former Angola Airport facility and a gravel lot located on the east side of the facility. View is facing northwest from the gravel lot towards hangar buildings (*Panamerican 2021*).

- Grading and ditching within 100 ft of both elevated airstrips (see Appendix A: Photograph 15).
- Grading, gravel fill, and paved vehicle/aircraft access roads associated with the facility buildings in the southwest corner of the project area impact approximately 4.9 acres (see Appendix A: Photographs 16 and 17).

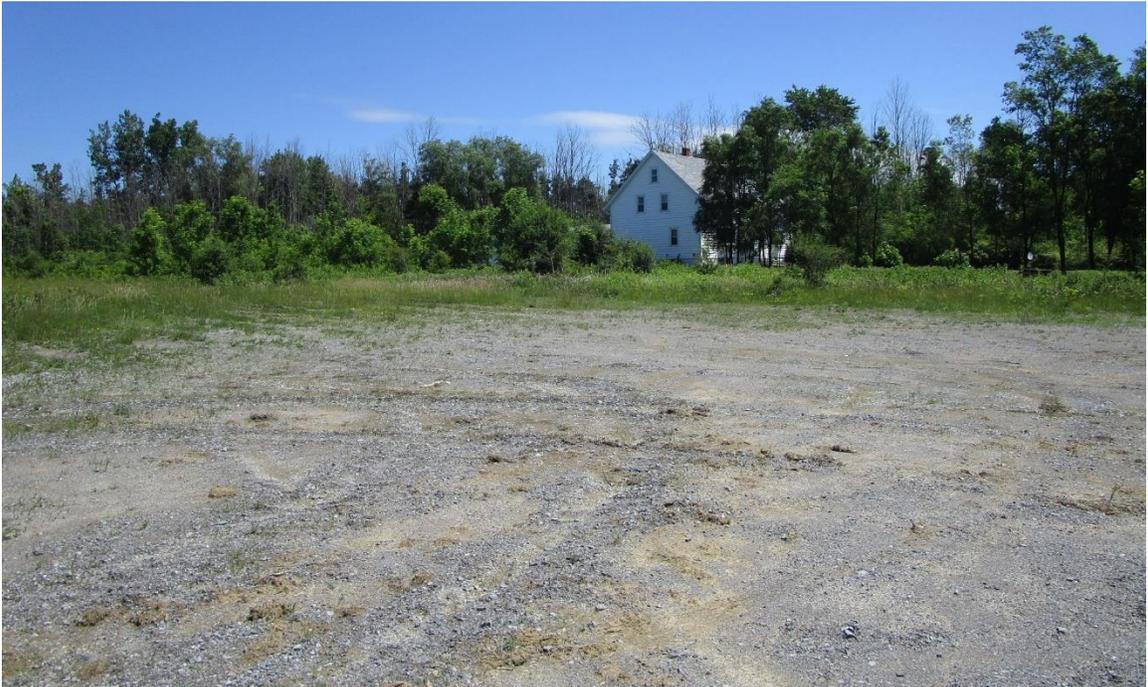
Photograph 18. Gravel lot disturbance on east side of the former Angola Airport facility. View is facing northeast towards residence at 1548 Eden Evans Center (shown in Photograph 13) – located within the project (*Panamerican 2021*).

- Gravel lot adjacent to Eden Evans Center Road and east of the former airport building (see Appendix A: Photograph 18).
- Undetermined if the two residences within the project have backyard septic systems or are connected to a municipal waste system.

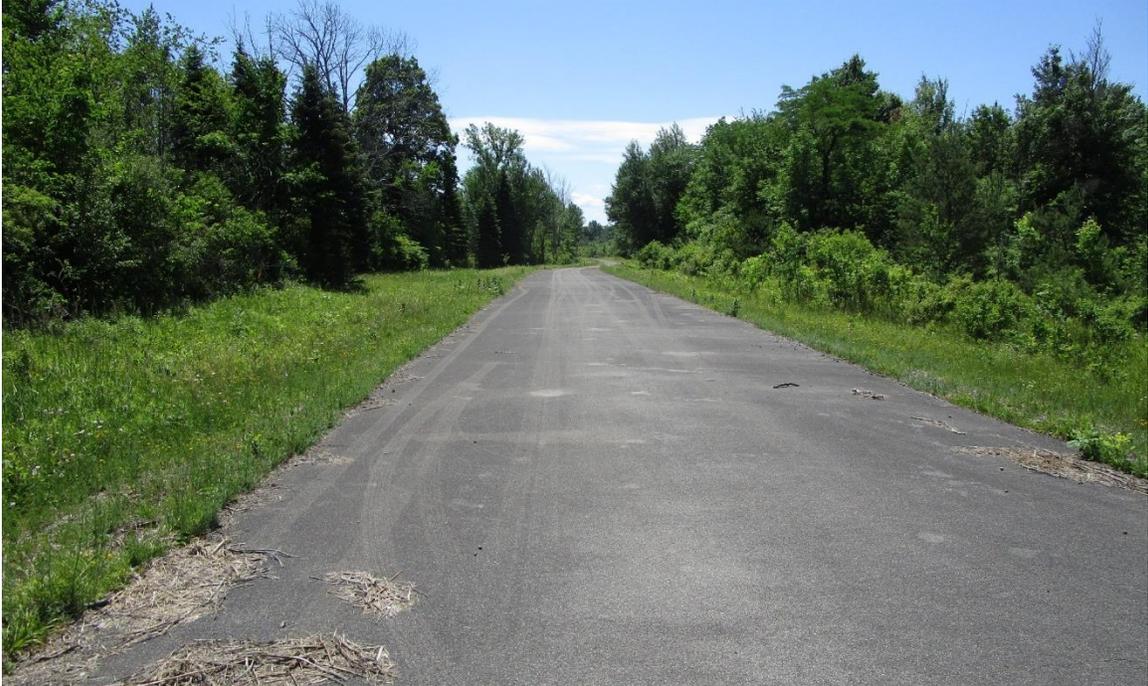
Photograph 19. Paved access road extending south from the airplane parking area to Eden Evans Center Road. View is facing south (*Panamerican 2021*).

- Partial gravel and paved access road extending from the aircraft parking lot to Eden Evans Center Road is elevated 1.5 meters (5 ft) in the north portion – with an elevated gravel lot extension at the north terminus (see Appendix A: Photographs 19 and 20). A 10-ft wide disturbance along each side of the access road is anticipated due to road construction activities (tree/brush removal, grading and fill).

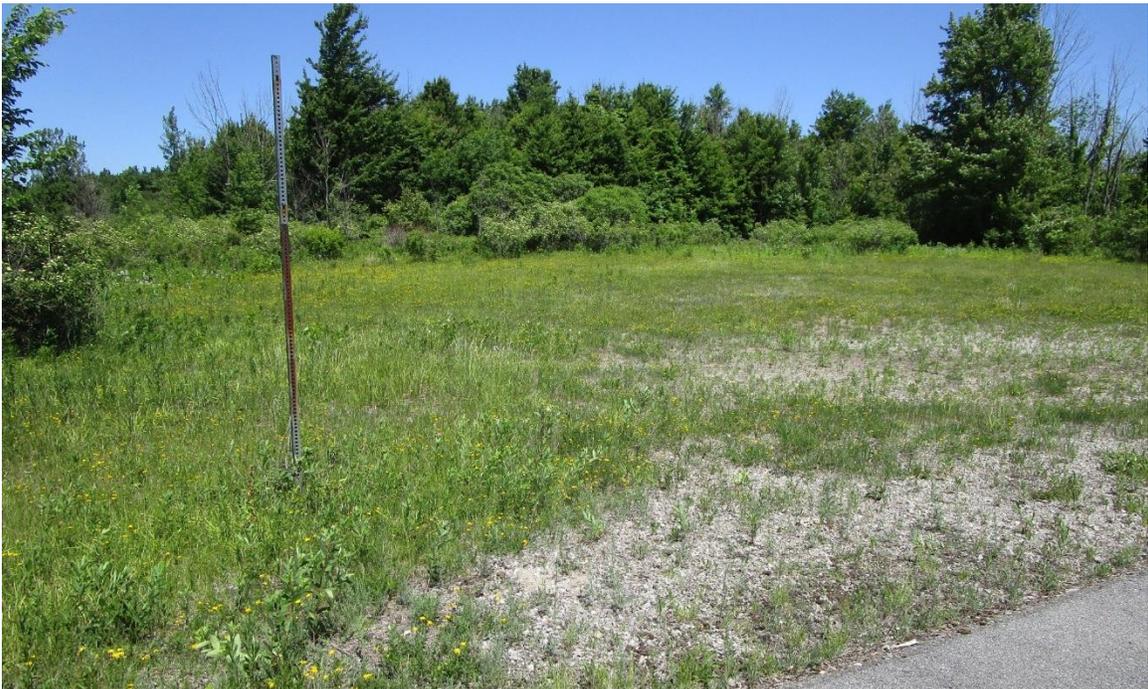
Photograph 20. Elevated gravel filled lot located at north terminus of the paved access road shown in Photograph 19. View is facing northeast (*Panamerican 2021*).

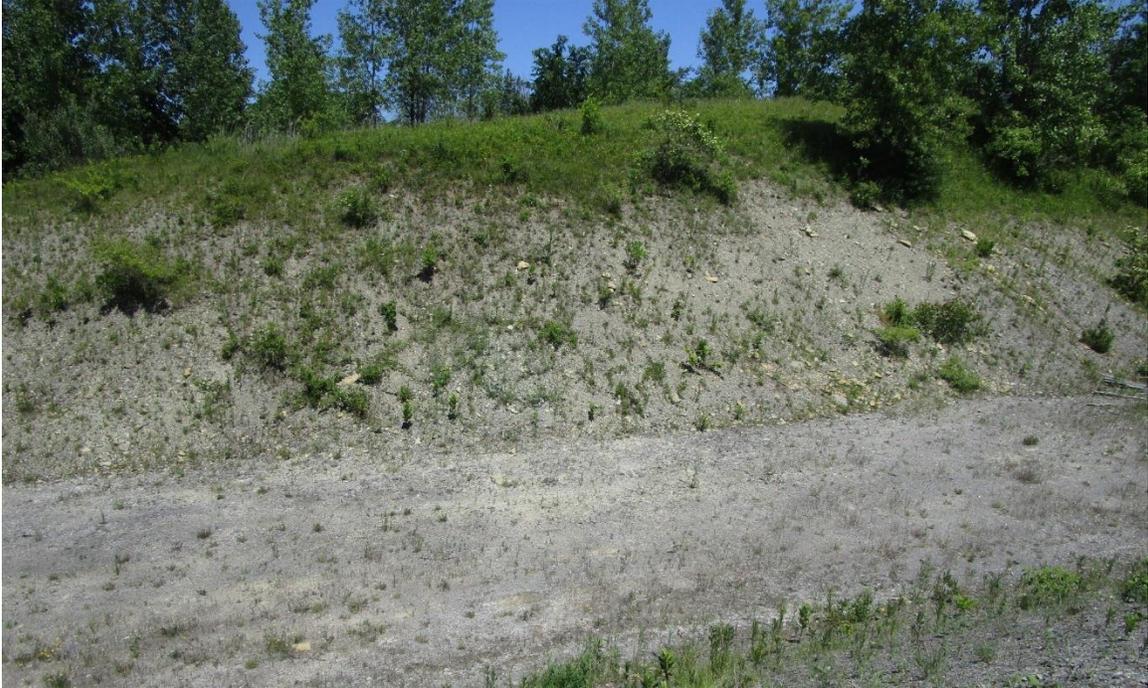
Photograph 21. Two large gravel piles between 200-ft and 300-ft length are found on the east side of the airplane parking area. View is facing northwest (*Panamerican 2021*).

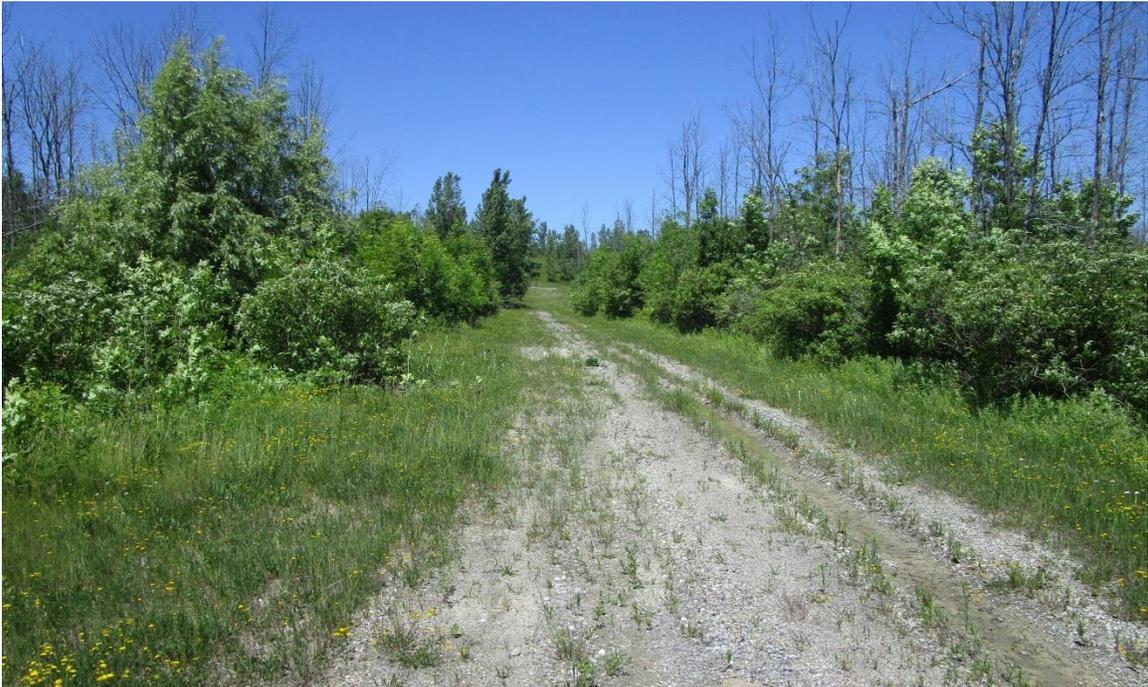
Photograph 22. Gravel access road extending south from the two large gravel piles shown in Photograph 21 to Eden Evans Center Road. View is facing south (*Panamerican 2021*).

- Gravel access road extending from the east side of the two gravel piles mentioned above, extending south towards Eden Evans Center Road. A 10-ft wide disturbance along each side of the access road is anticipated due to road construction activities (tree/brush removal, grading and fill) (see Appendix A: Photograph 22).

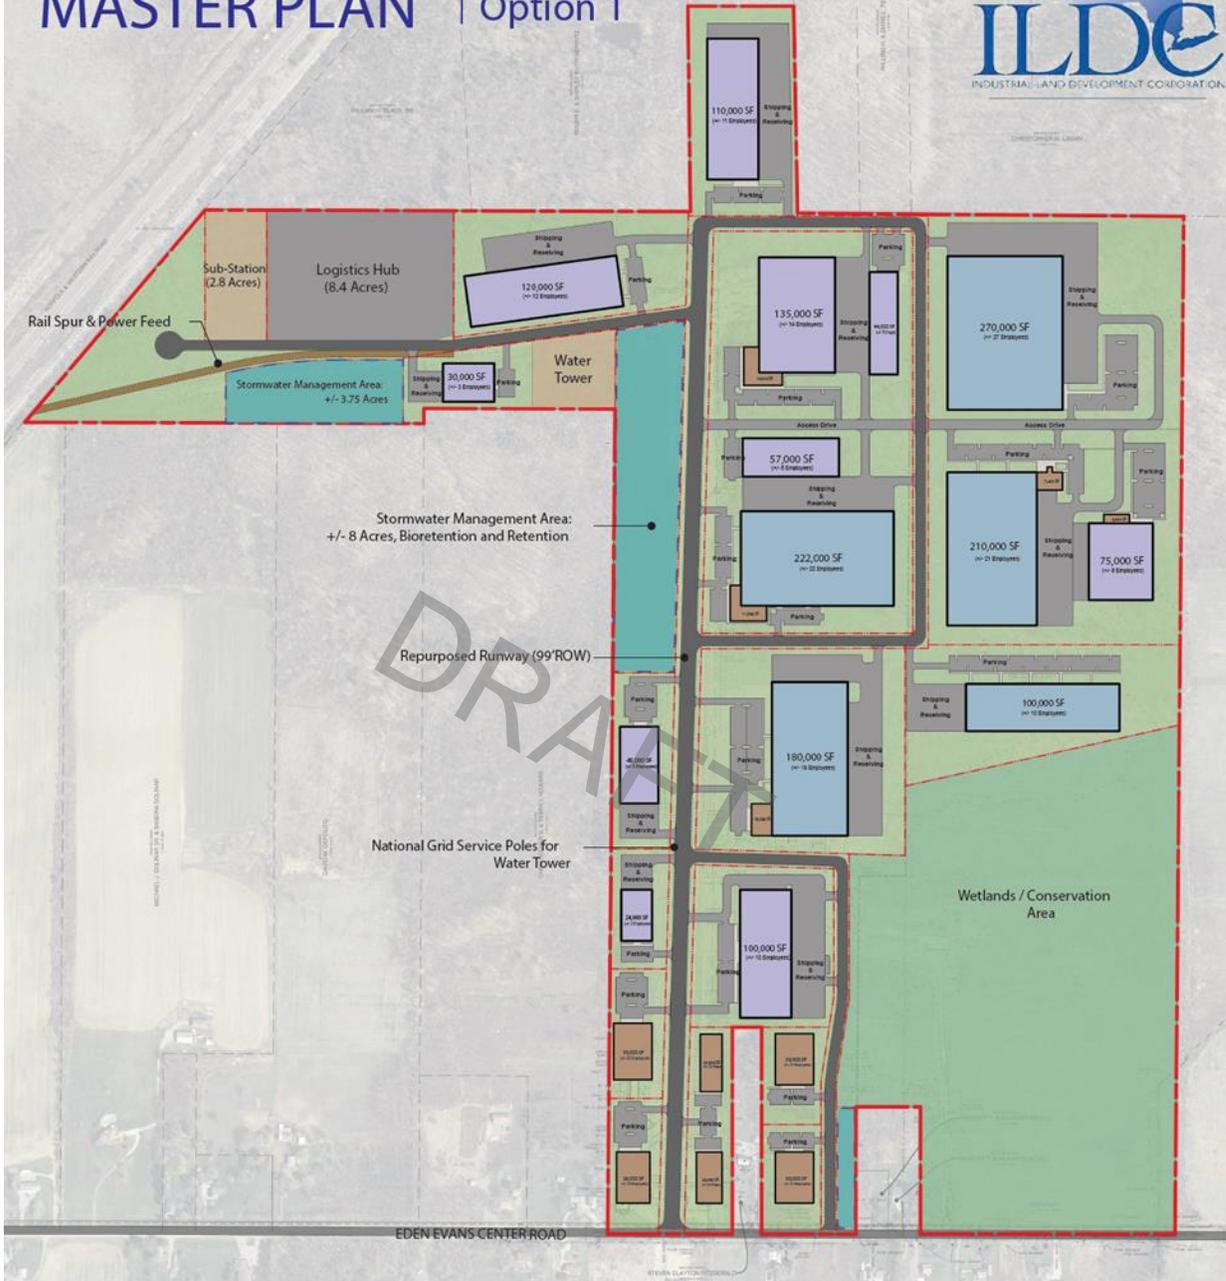
ERIE COUNTY AGRIBUSINESS PARK MASTER PLAN | Option 1

- Legend:**
- Overall Property Line
 - Parcel Boundaries
 - Stormwater Detention Area
 - Wetlands - Conservation Area
 - Controlled Growth Facility
 - Cold Storage Facility
 - Office Space

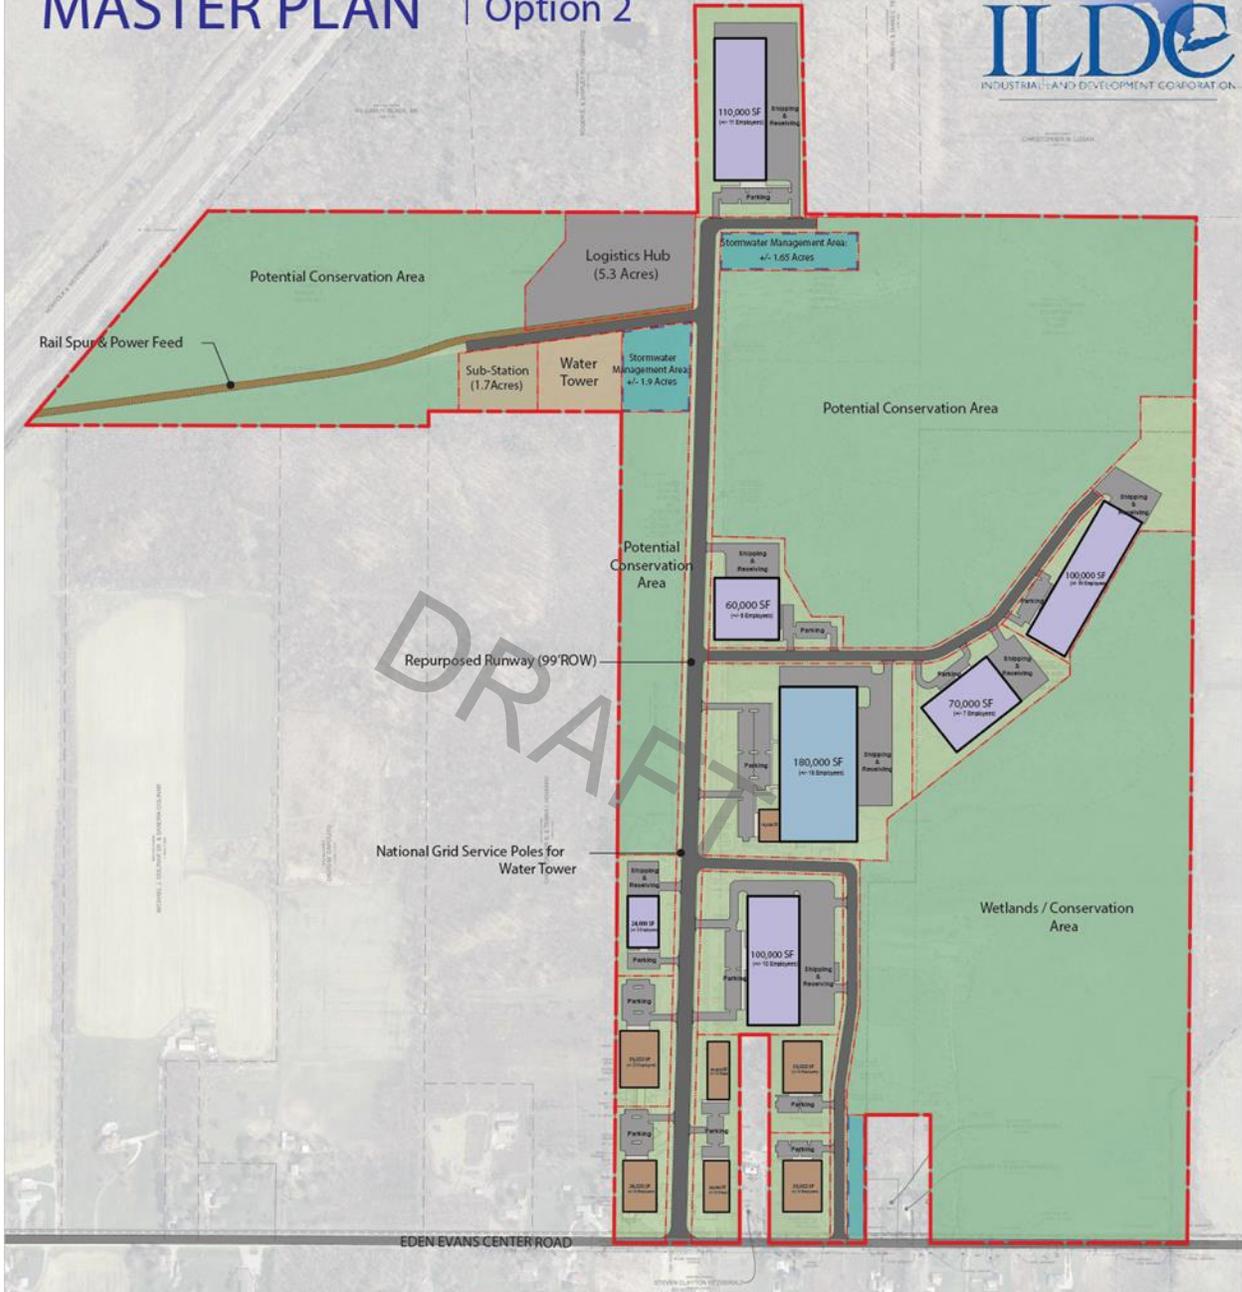
ERIE COUNTY AGRIBUSINESS PARK MASTER PLAN | Option 2

- Legend:**
- Overall Property Line
 - Parcel Boundaries
 - Stormwater Detention Area
 - Wetlands - Conservation Area
 - Controlled Growth Facility
 - Cold Storage Facility
 - Office Space

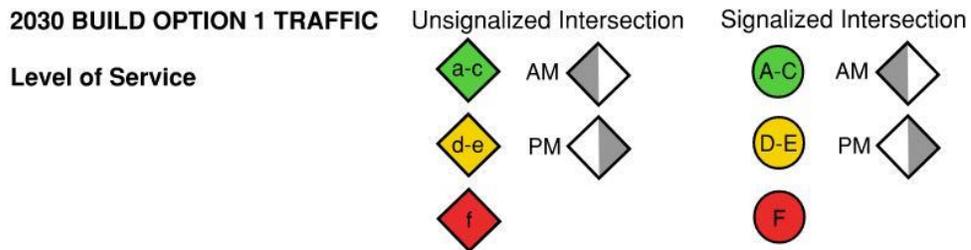
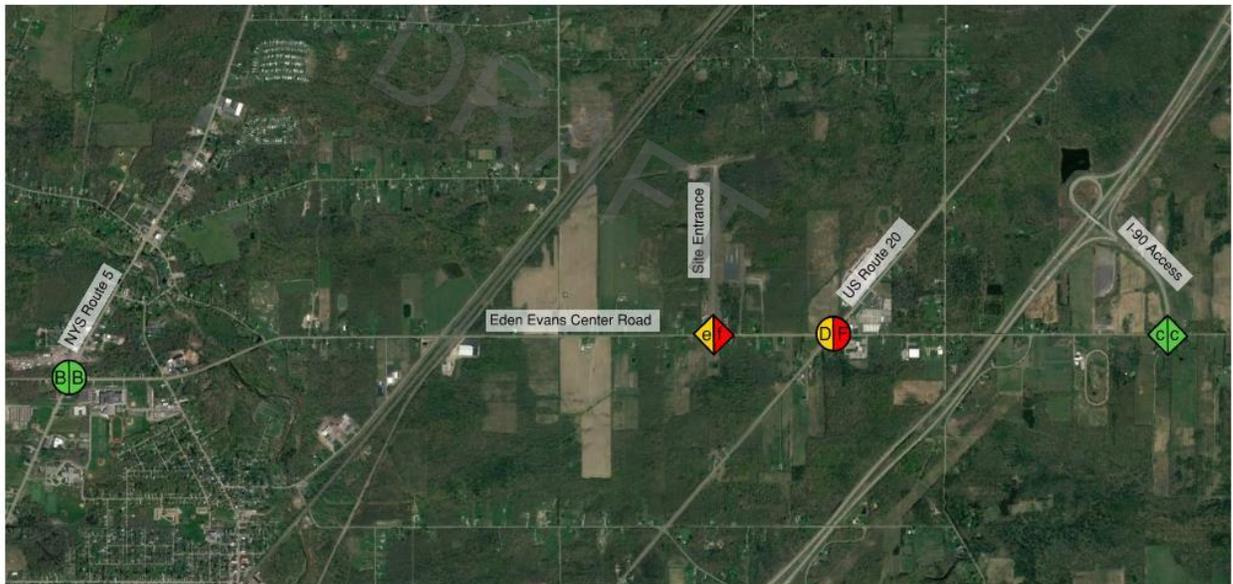
Figure 11: Option 1 Intersection Level of Service

Level of service and queue analyses were prepared for the Option 1 Build Scenario. Results of these analyses are summarized in the tables that are included in Appendix B – Level of Service and Queue Summary and discussed below. LOS results for Option 1 are illustrated in Figure 11.
